Great Sandy Strait Biopassage Remediation Project – Final Report

REDUCING THREATS TO THE GREAT SANDY STRAIT RAMSAR
WETLAND & COASTAL SYSTEMS

November 2012

Report to the Burnett Mary Regional Group for Natural Resource Management

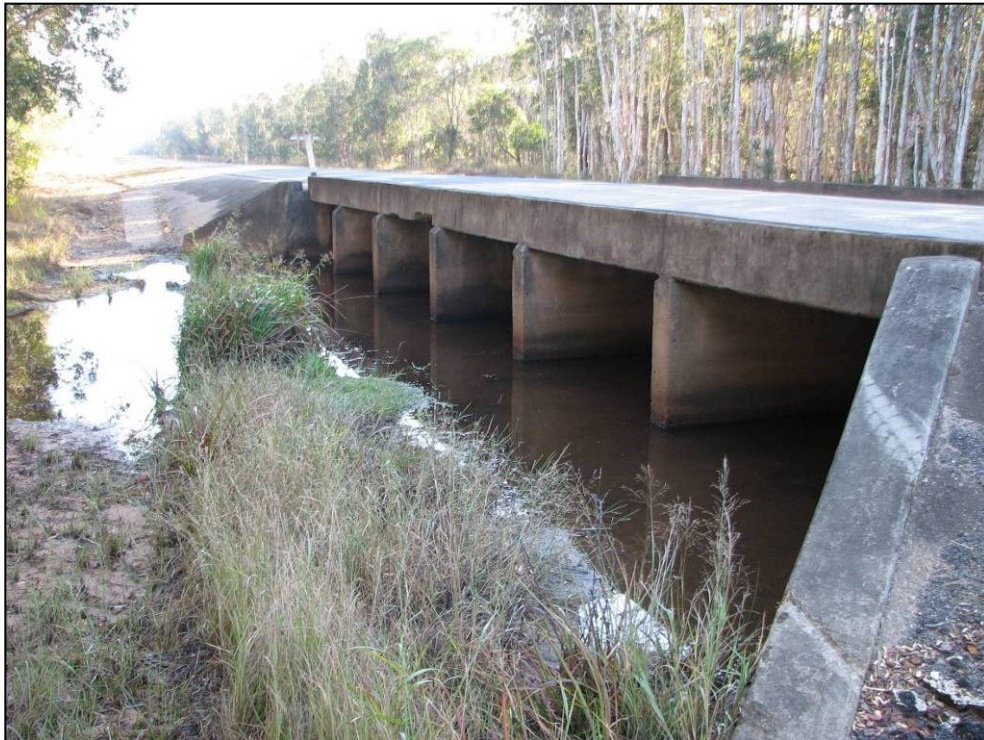
The Little Tuan Creek crossing is a six cell rectangular box culvert set on a concrete base that is perched above the natural level of the creek bed and approximately equal to the commence to flow water level (Figure 9). The crossing was identified as a barrier to fish movement during low to moderate flows. In a natural creek bed the water forms a defined low flow channel of varying depths. Low flows over the crossing pass through all six culvert barrels creating a shallow laminar flow that restricts fish passage and increases predation by birds. No hydraulic studies of the culvert were performed; however it is likely that at higher flows the increased water velocities create a barrier to the successful passage of fish.

Figure 9. Cooloola Coast Road crossing of Little Tuan Creek prior to biopassage remediation.

The biopassage remediation works for the Little Tuan Crossing consisted of the installation of low sills on the culvert base and baffles on the outside culvert walls (Figure 10). The function of the sills is to block low flows through five of the culvert barrels thereby increasing the depth in the right bank side culvert to create a low flow pathway for fish. The function of the baffles is to disrupt the flow patterns on the culvert walls in a similar way to the natural vegetation in a creek. Baffles fitted to both walls of the designated low flow culvert and to the outside wall of the left bank culvert provide the best combination of hydraulic conditions for biopassage in multi-cell culvert arrays.

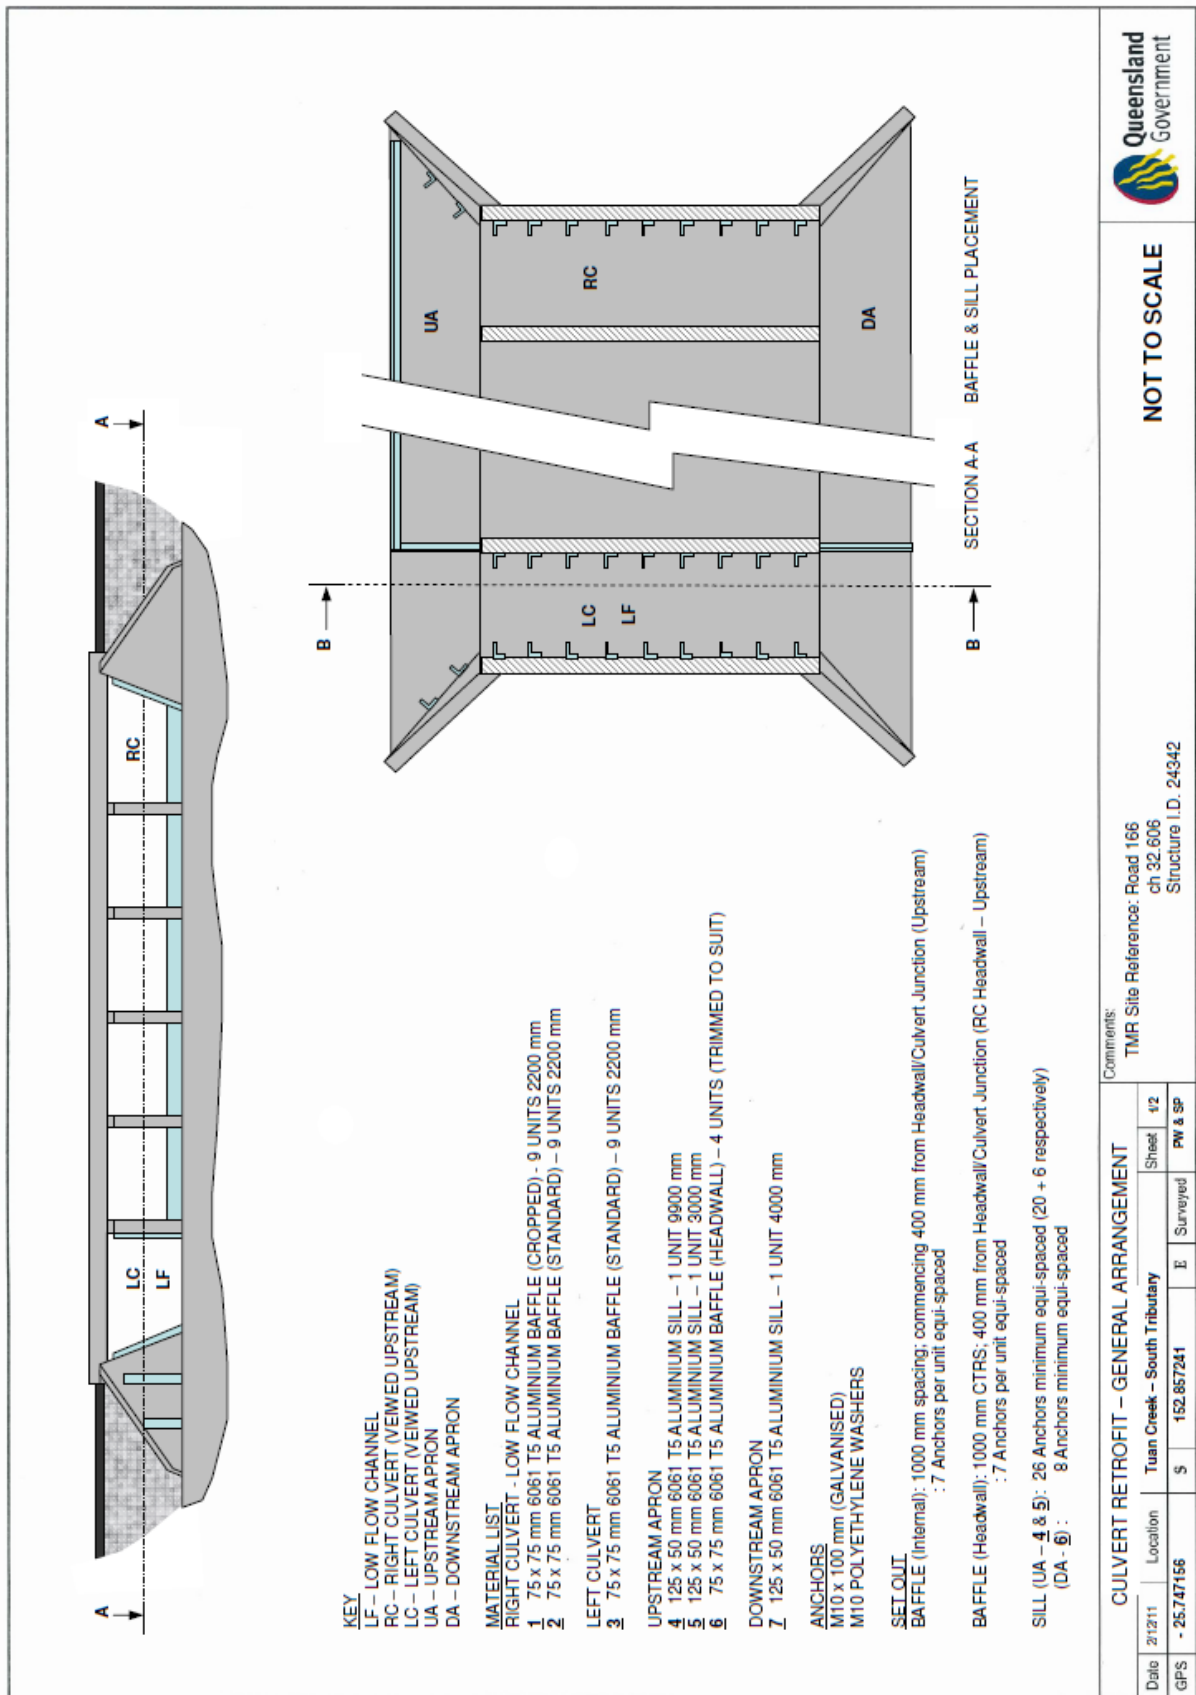
Figure 10. Schematic of culvert retrofit for biopassage remediation at the Little Tuan Creek site.

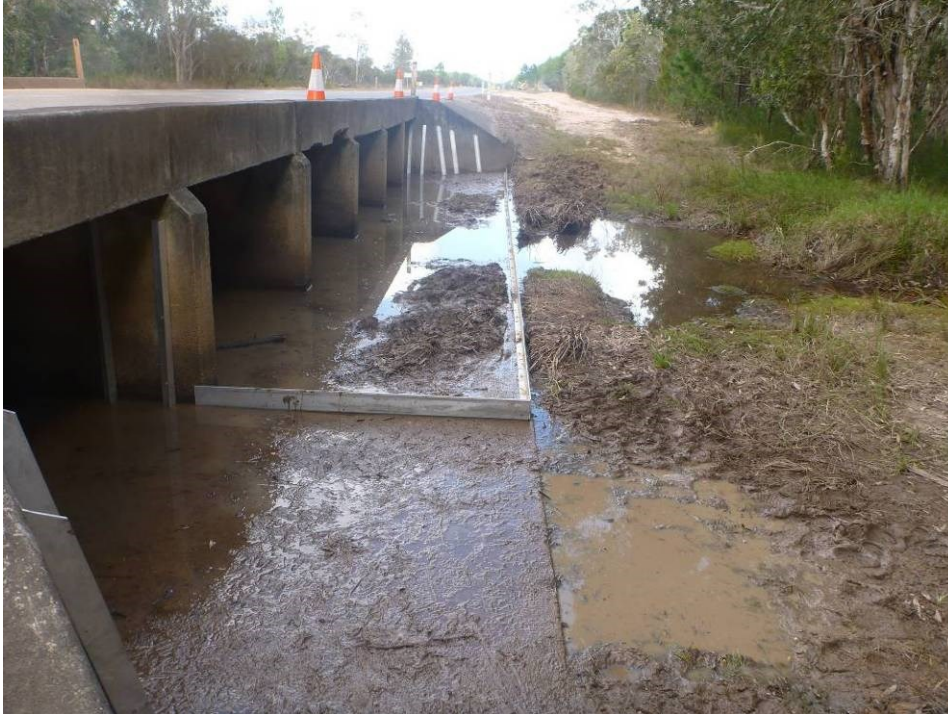
Figure 11. Biopassage remediation works installed at the upstream side of the Little Tuan Creek crossing of the Cooloola Coast Road showing the low flow culvert and baffles in the foreground and the high flow culvert in the background.

Remediation works were delayed by flows in Little Tuan Creek until August. Figures 11 and 12 demonstrate the upstream and downstream aspects of the Little Tuan Creek crossing including the low flow culvert and high flow culvert baffles.

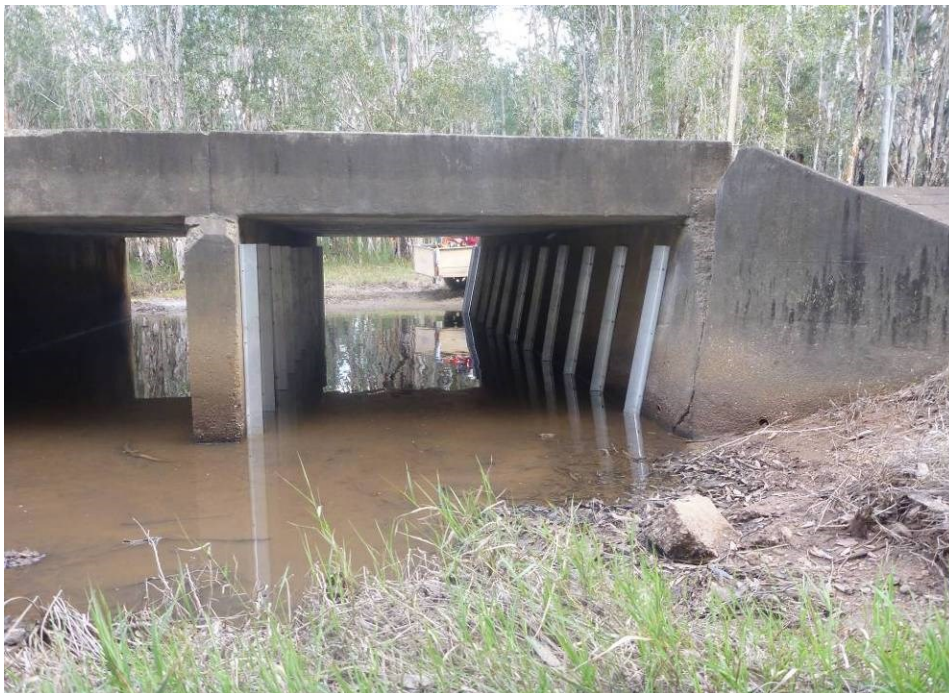
Figure 12. Biopassage remediation works installed at the Little Tuan Creek crossing of the Cooloola Coast Road taken from downstream and showing the low flow culvert and baffles.

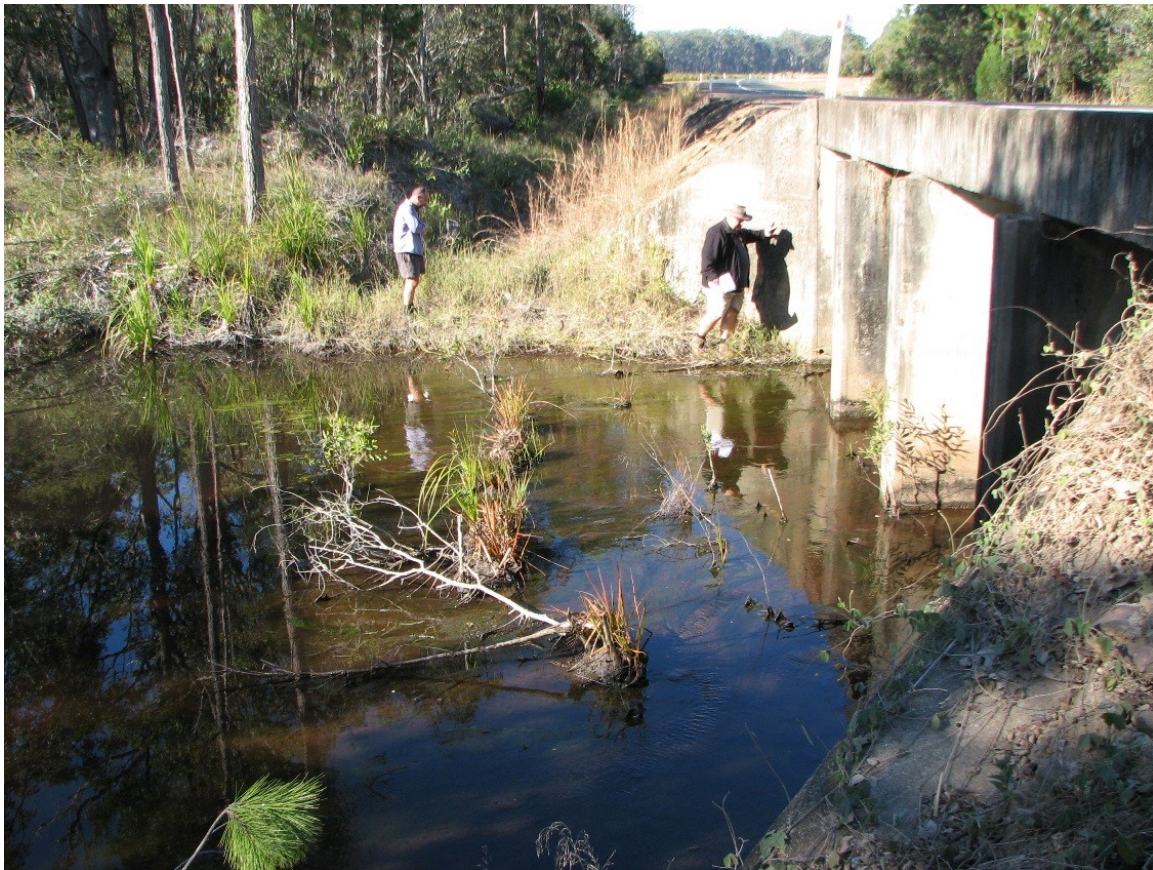
The Scrubby Creek crossing is a four cell rectangular box culvert set on a concrete base that is perched above the natural level of the creek bed and slightly below the commence to flow water level (Figure 14). The unmodified crossing was a barrier to fish movement during low to moderate flows. In a natural creek bed the water forms a defined low flow channel of varying depths. Low flows over the crossing pass through all four culvert barrels creating a shallow laminar flow that restricts fish passage and increases predation by birds. No hydraulic studies of the culvert were performed; however it is likely that at elevated flows the higher water velocities create a barrier for the passage of fish.

Figure 14. Cooloola Coast Road crossing of Scrubby Creek prior to biopassage remediation.

The biopassage remediation works for the Scrubby Creek crossing consisted of the installation of low sills on the culvert base and baffles on the outside culvert walls (Figure 15). The function of the sills is to block low flows through five of the culvert barrels thereby increasing the depth in the right bank side culvert to create a low flow pathway for fish. The function of the baffles is to disrupt the flow patterns on the culvert walls in a similar way to the natural vegetation in a creek. Baffles fitted to both walls of the designated low flow culvert and to the outside wall of the left bank culvert provide the best combination of hydraulic conditions for biopassage in multi-cell culvert arrays.

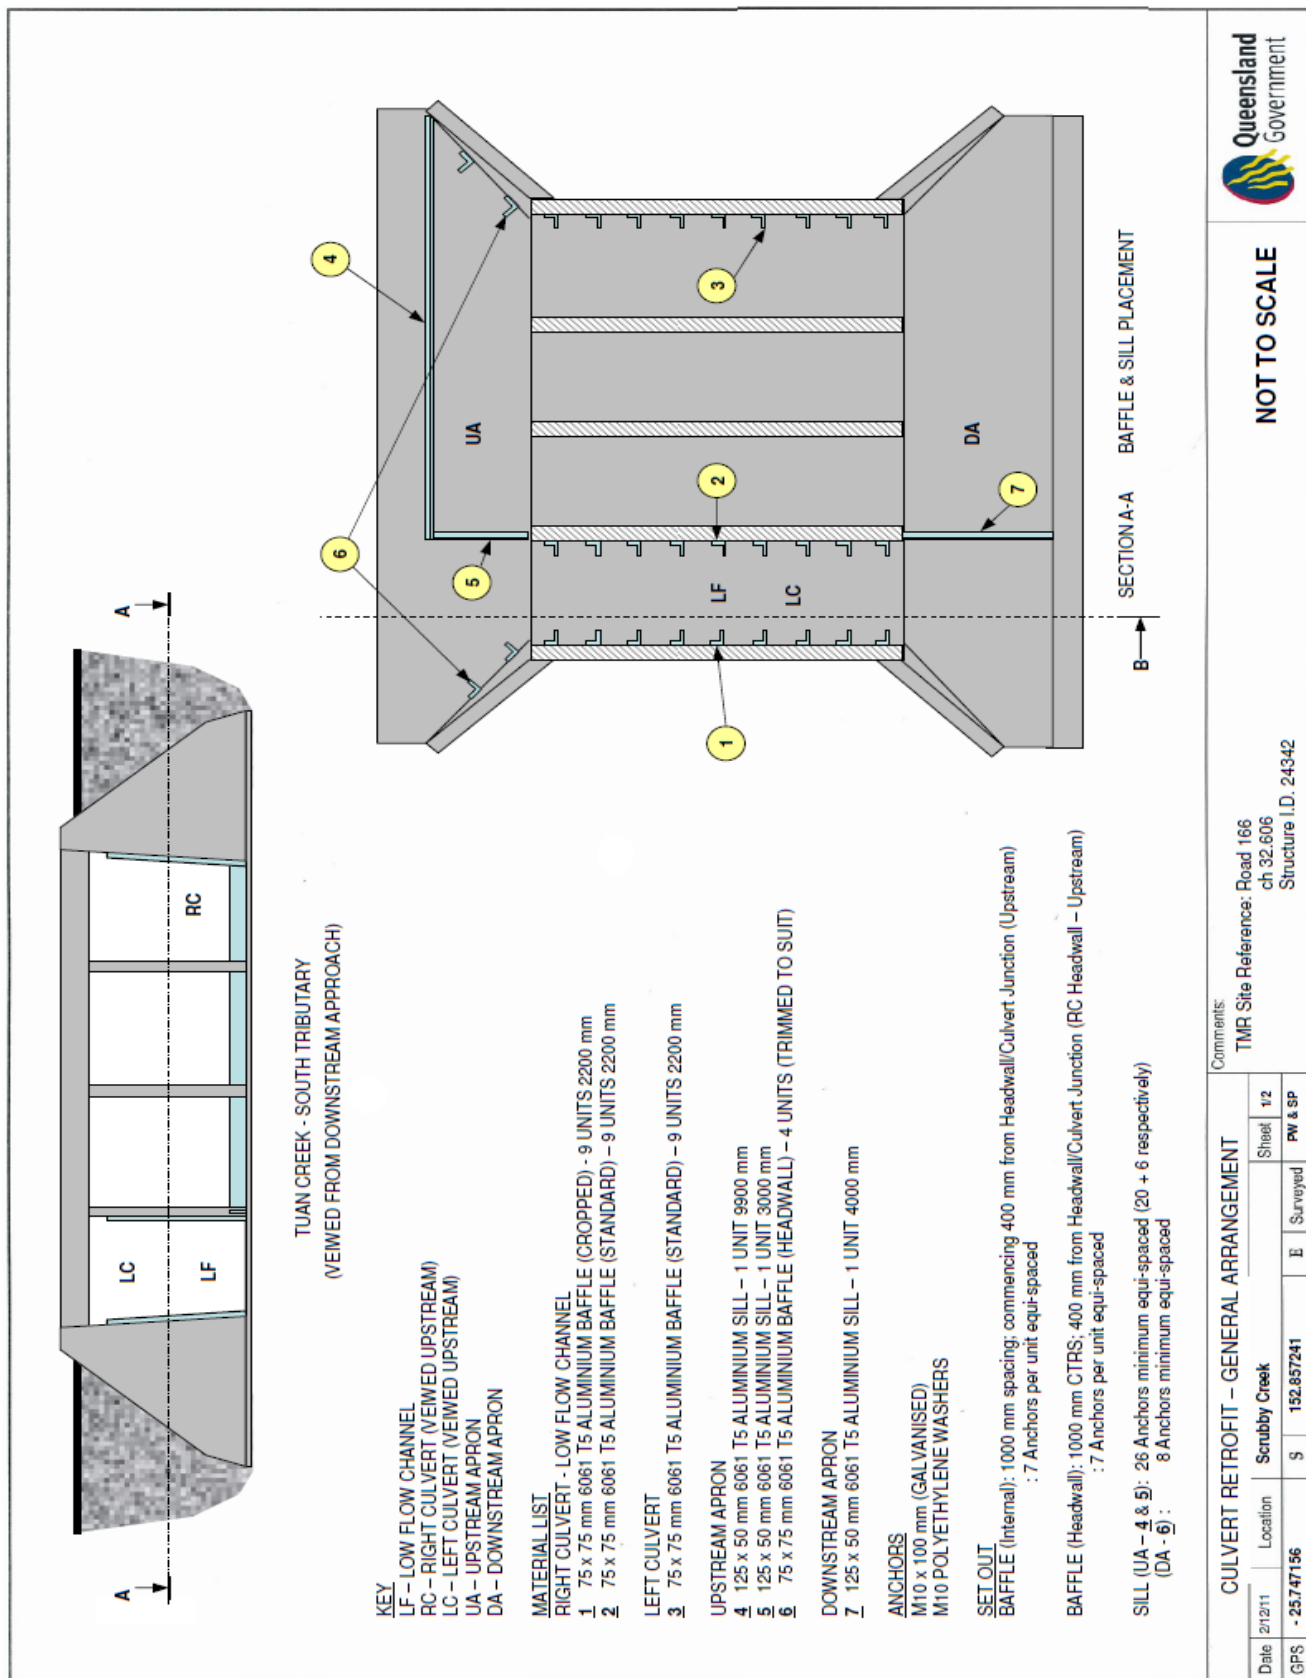
Figure 15. Schematic of culvert retrofit for biopassage remediation at the Little Tuan Creek site.

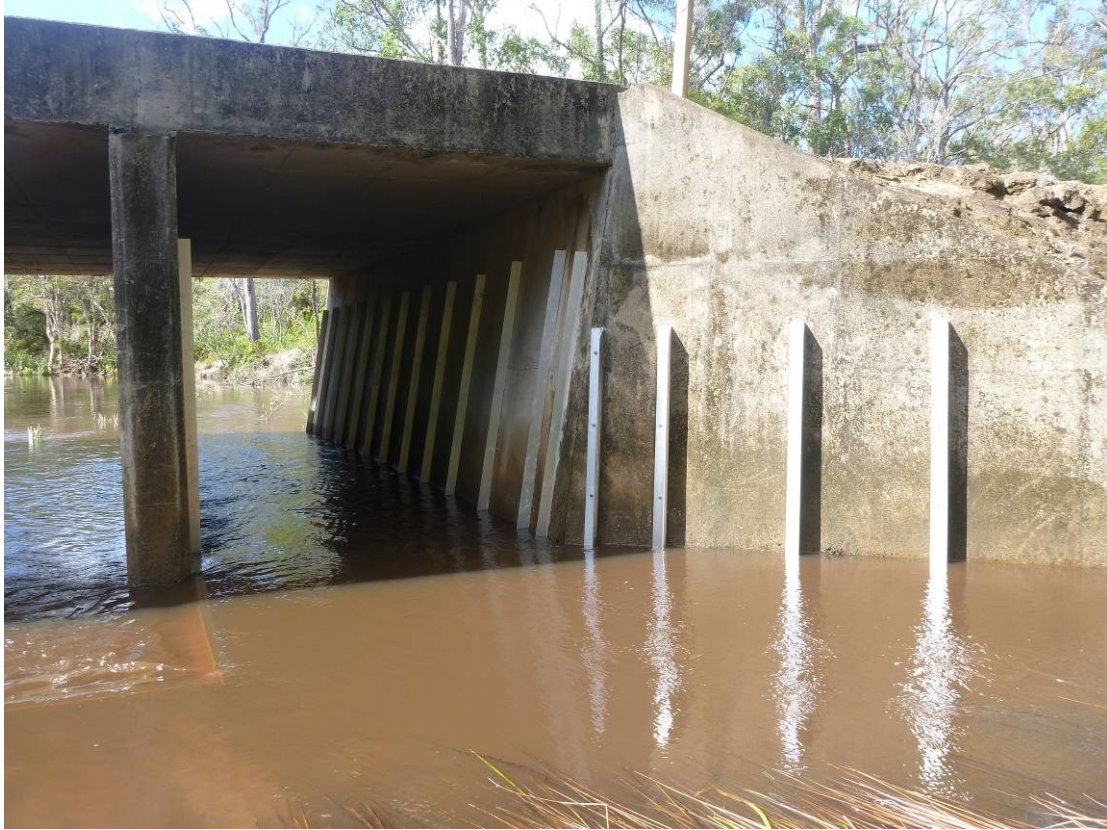
Remediation works were completed in May 2012. Almost immediately following baffle installation a local rainfall event caused a minor flow in Scrubby Creek. Figure 16 below shows the low flow culvert during this flow event and also demonstrates the effect that the baffles have on the flow patterns within the low flow culvert.

Figure 16. Biopassage remediation works installed at the Scrubby Creek crossing of the Cooloola Coast Road showing the low flow culvert and baffles.

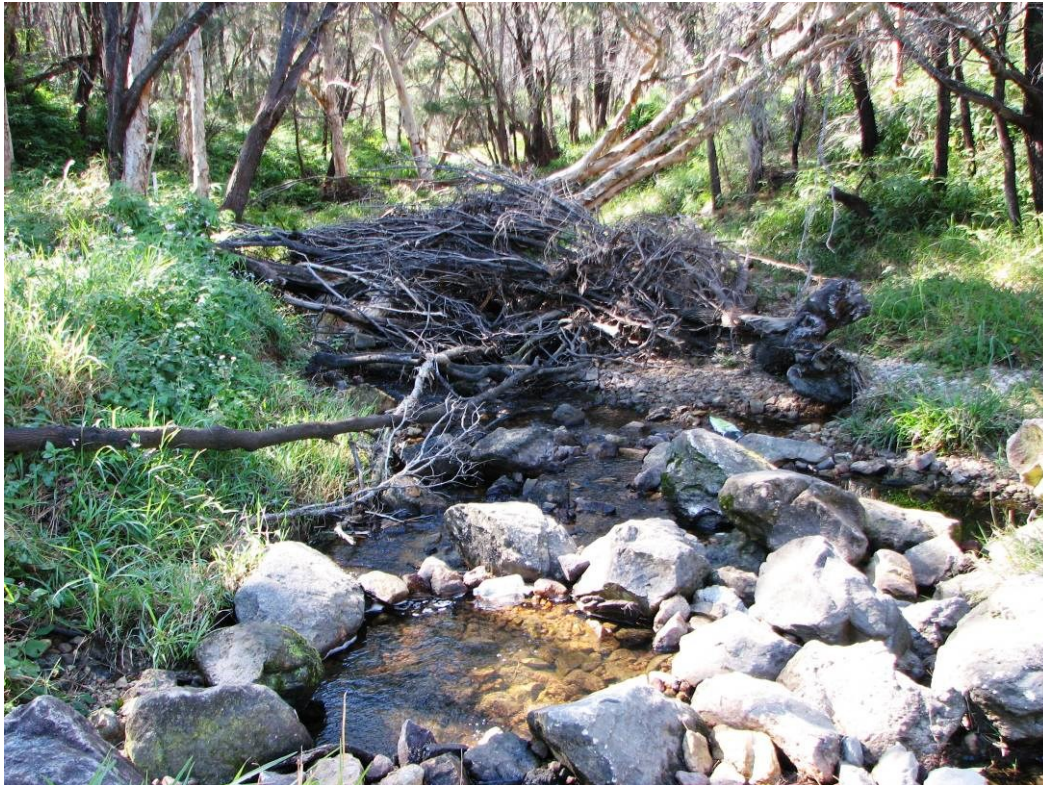
The Trib of Mullen Creek crossing is on Queen Elizabeth Drive and is a low level structure consisting gravel and rock utilised by recreational off-roaders and bushwalkers. Prior to remediation, the lowest point of the crossing was set above the natural bed level with a low slope of gravel, large rocks and debris extending approximately 15 m downstream (Figure 18). All flows in the creek passed over the crossing and through or over the gravel, rocks and debris. The passage of aquatic fauna during low flows was hampered by the arrangement of the rocks and gravel bars formed from erosion of the crossing during flows.

Figure 18. Queen Elizabeth Drive crossing of Trib of Mullen Creek in August 2011 prior to remediation.

A biopassage remediation solution for the Trib of Mullen Creek crossing was the re-construction of the crossing with suitable capacity baffled box culverts that span the full width of the low flow channel. However the gravel section of Queen Elizabeth Drive is currently not used for regular traffic of vehicles or maintained by the Gympie Regional Council and as such re-construction work is currently not economically viable. A more suitable solution was to adjust the gradient downstream of the crossing and realign the rocks to provide suitable velocity refuges for the passage of small fish and other aquatic fauna.

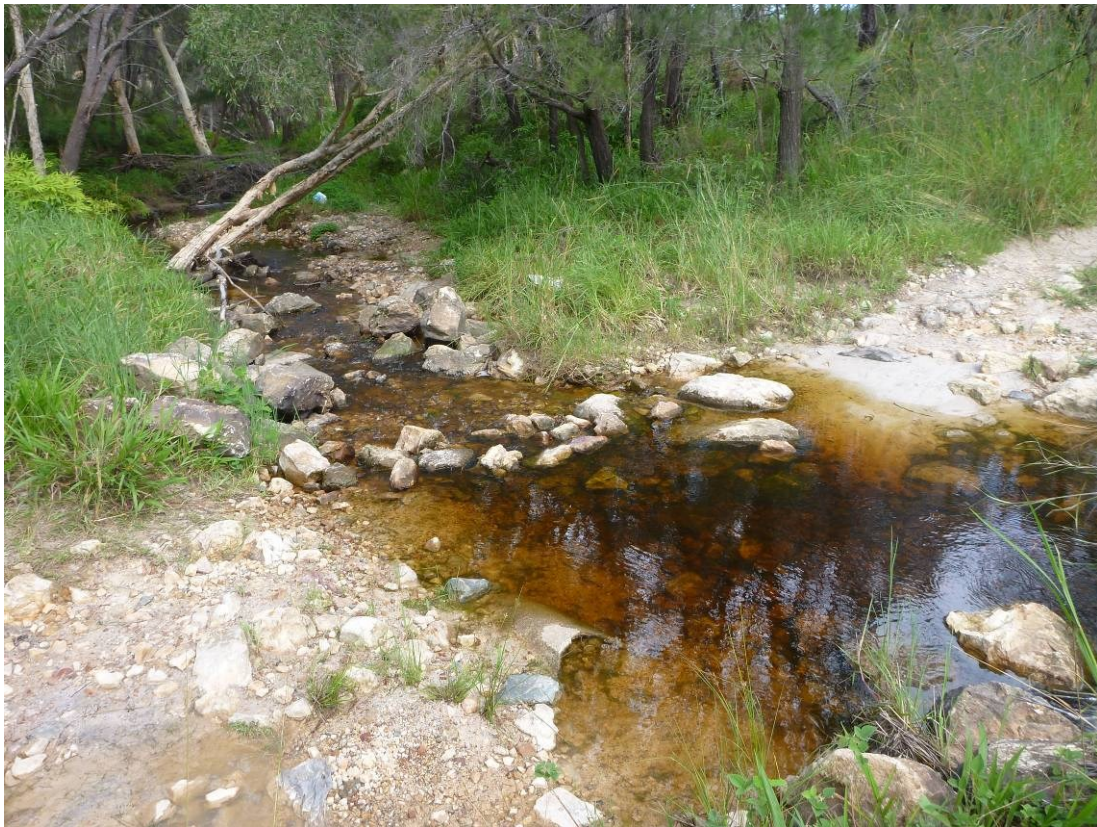
Figure 19. Trib of Mullen Creek crossing in January 2012 following remediation by Gympie Regional Council.

In late 2011 Gympie Regional Council staff from the Tin Can Bay works depot modified the crossing as specified above and shown below in Figure 19. Minor modifications to the crossing and the area downstream to facilitate fish passage have provided a suitable solution without major works or expense. The current gradient of the ramp downstream of the crossing would be suitable for small fish passage. Realignment of the rocks has provided velocity refuges for fish and removal of the gravel bar and debris raft have made a substantial improvement in the passage of fish beyond the crossing.

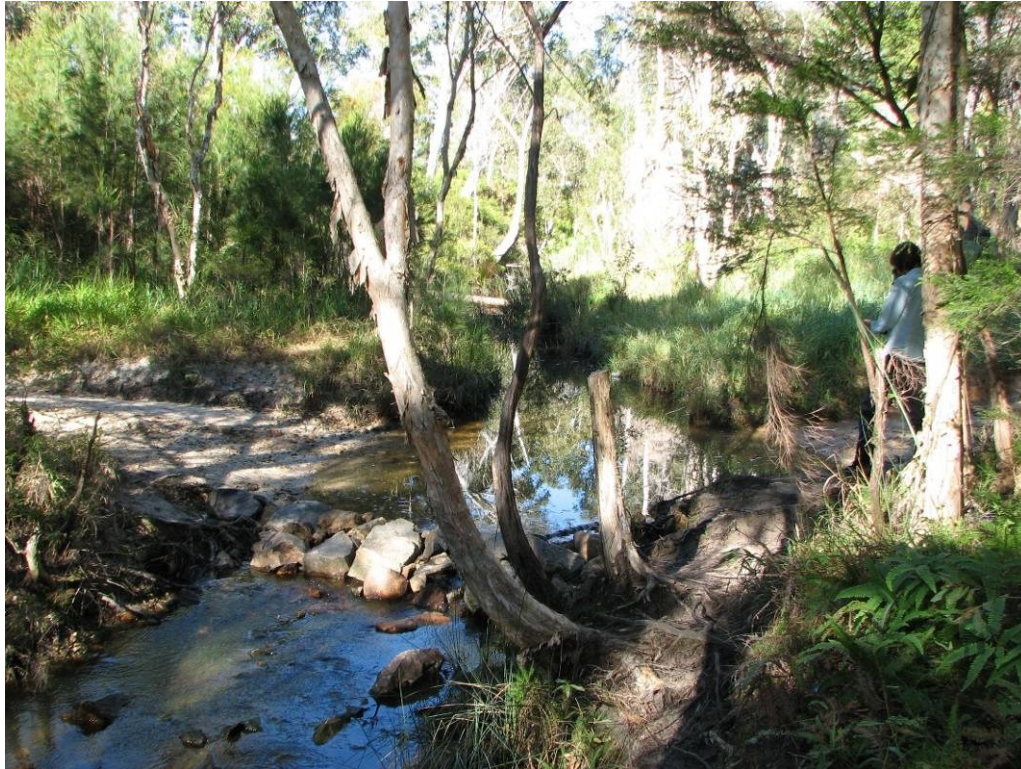
The Mullen Creek lower crossing is on Queen Elizabeth Drive and is a low level structure consisting gravel and rock utilised by bushwalkers, recreational off-roaders and the Gympie Regional Council for access to pumps. Prior to remediation the lowest point of the crossing was set above the natural bed level with a low slope of gravel, and rocks extending downstream (Figure 21). All flows in the creek passed over the crossing and through or over the gravel, rocks and debris. The passage of fish during low flows was hampered by the arrangement of the rocks and gravel bars formed from erosion of the crossing during flows.

Figure 21. Mullen Creek lower crossing in August 2011 prior to remediation.

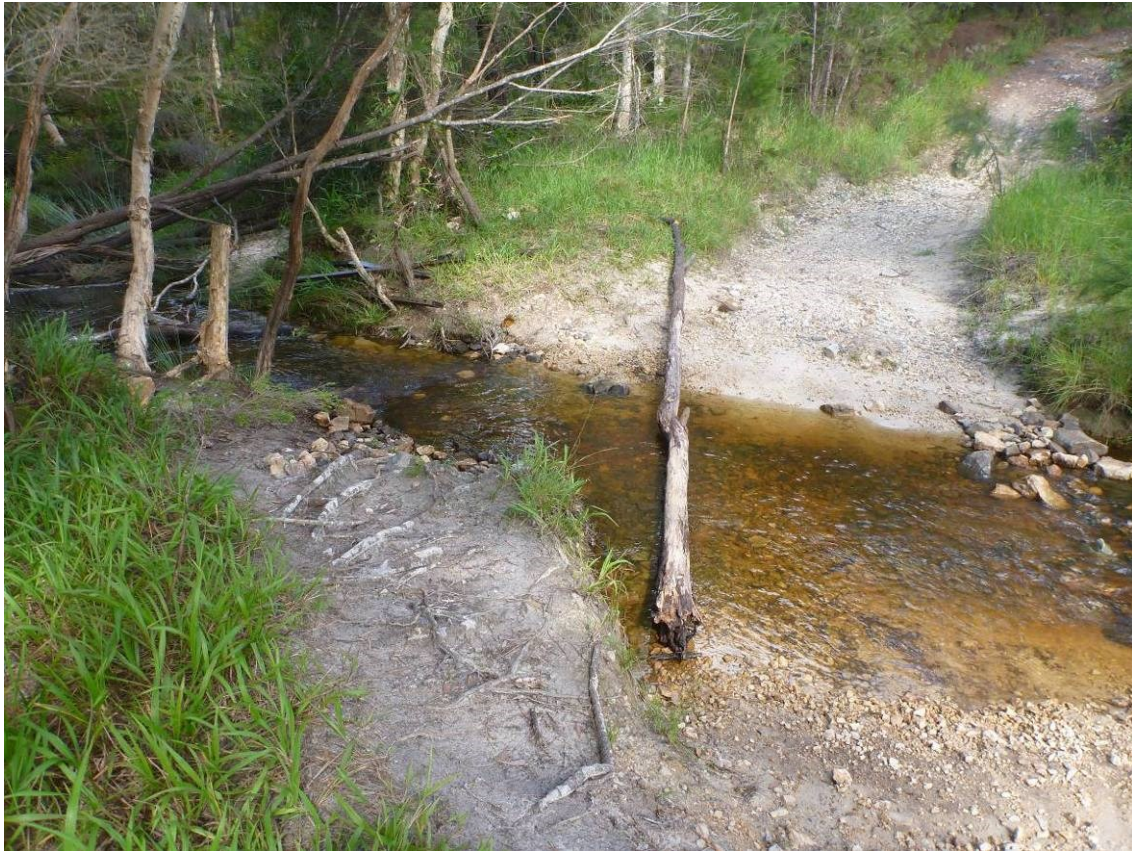
Figure 22. Mullen Creek lower crossing in January 2012 following remediation by Gympie Regional Council.

In late 2011 Gympie Regional Council staff from the Tin Can Bay works depot modified the crossing as shown below in Figure 22. Minor modifications to the crossing and the area downstream to facilitate fish passage have provided a suitable solution without major works or expense. The current gradient of the ramp downstream of the crossing would be suitable for small fish passage. Realignment of the rocks has provided velocity refuges for fish and has made a substantial improvement in the passage of fish beyond the crossing. An important factor in maintaining fish passage at this site will be the maintenance of the flow pathways achieved by the modifications.

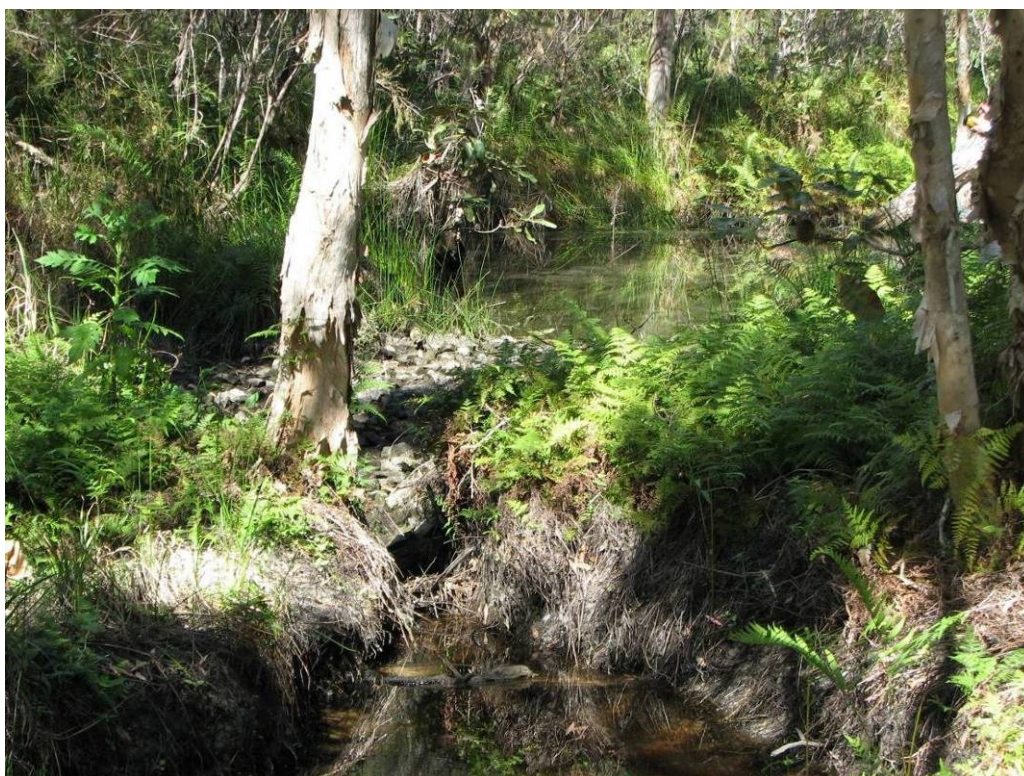
The crossing was constructed of gravel and earth at 0.6 m above the natural bed level with no drainage, effectively creating a weir type barrier under all low to moderate flow conditions (Figure 24). Biopassage remediation of the crossing of the creek could be effected by re-construction of the crossing with baffled box culverts that span the full width of the low flow channel. However given that the track appears unused and in very poor condition such re-construction work was not considered necessary.

Figure 24. Crossing of Un-named Creek of Carland Ck inlet in August 2011 prior to biopassage remediation demonstrating the water level difference upstream and downstream of the crossing.

Lowering of the structure down to bed level was considered the most suitable solution to re-establish biopassage at the site. Removal of even a low structure requires some consideration in order to maintain the integrity of the stream bank and to minimise further damage to the riparian vegetation at the site. Accordingly, works to lower the structure were delayed until September 2012 to permit the height of the water table to be reduced following consistently heavy rainfall throughout the 2011-2012 summer wet season.

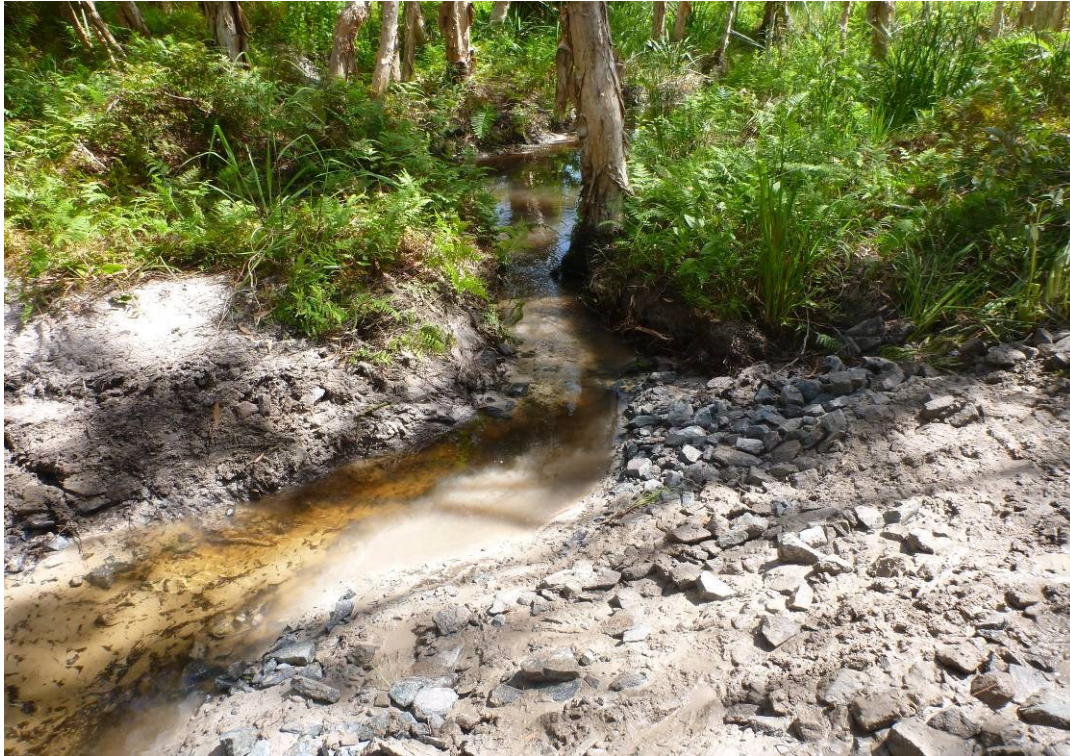
Figure 25. Crossing of Un-named Creek of Carland Ck inlet site in September 2012 following biopassage remediation. Image taken on the crossing looking downstream and demonstrating the linkage to the waterhole downstream.

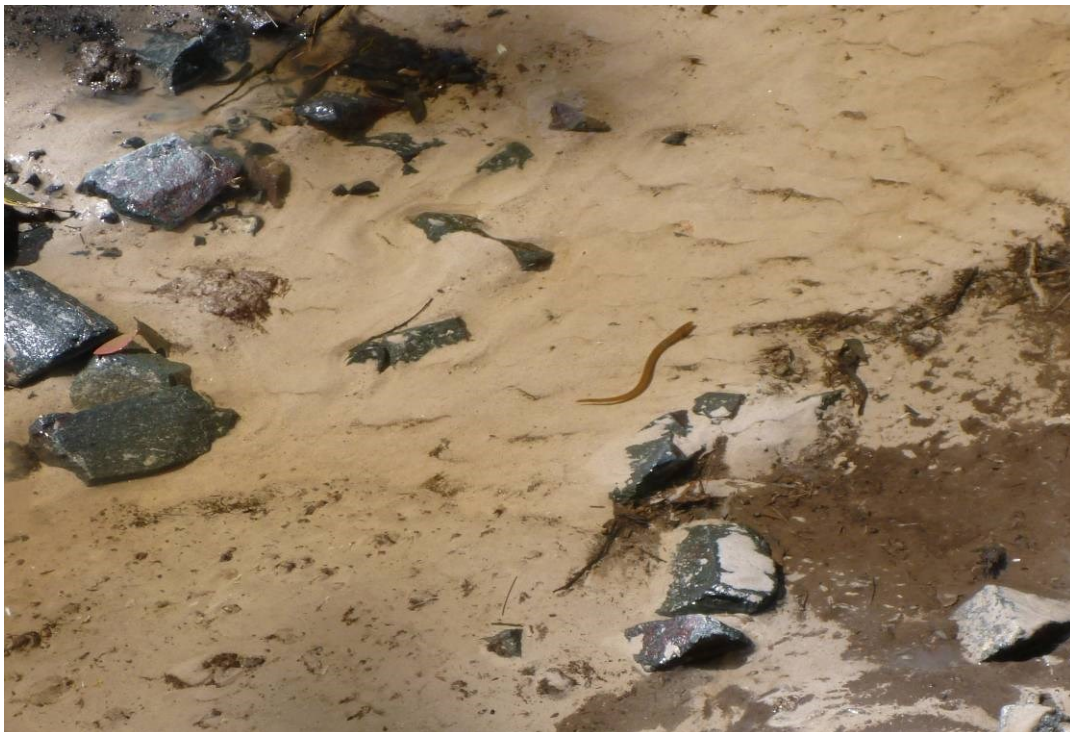
Aquatic fauna downstream of the crossing responded immediately to the flow triggered by the lowering of the weir. Shrimp, crabs and eels both sub-adult and juvenile were observed moving upstream over the crossing (Figure 26).

Figure 26. Juvenile eel moving upstream over the crossing of Un-named Creek of Carland Ck inlet site in September 2012 following biopassage remediation.

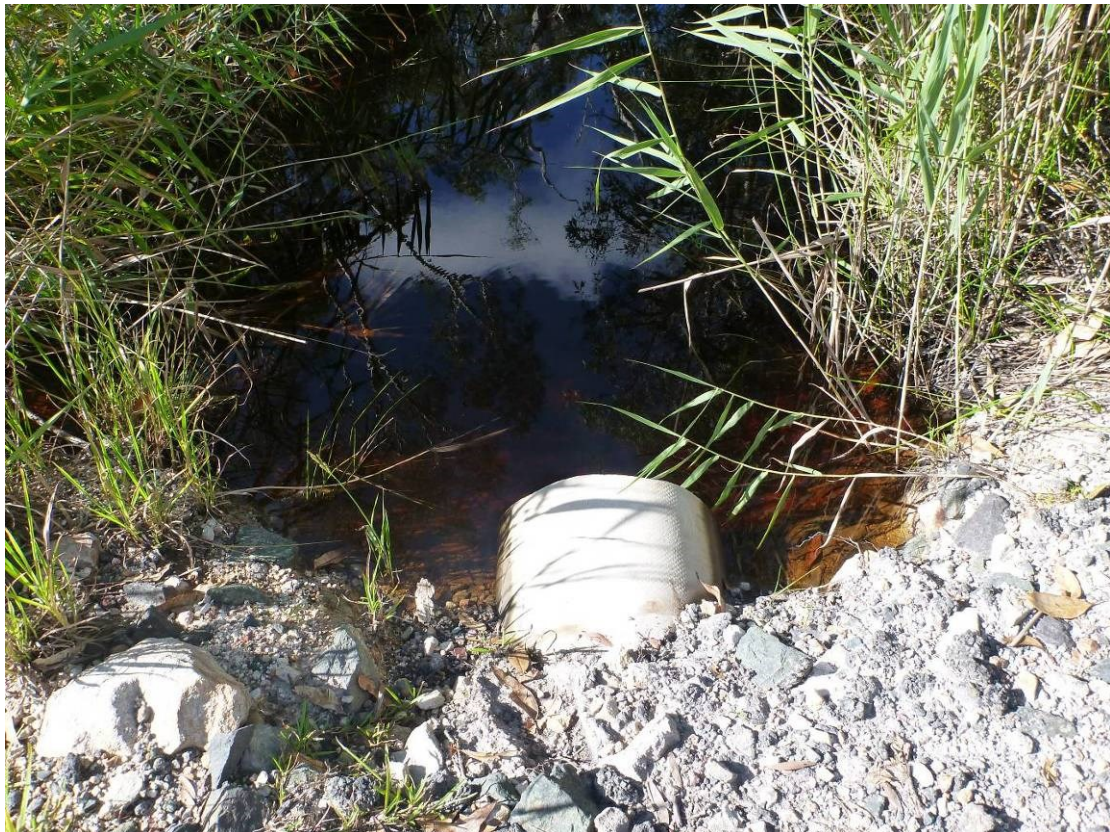
Figure 28. Downstream side of the Teewah Point Road crossing of Teewah Creek.

Biopassage remediation could be effected by re-construction of the crossing with a single 2.4 m wide box culvert that spans the low flow channel with baffling of the culvert walls and roughness in the culvert base.

No biopassage remediation works were performed within the current project at the Teewah Creek crossing. A cost estimate for the removal of the current pipe culvert and replacement with a baffled 2.4 m wide box culvert was estimated by Gympie Regional Council to be a minimum of \$60,000 (Greg Ingham GRC pers com.). The cost of remediating this site was beyond the budget of the current project. Funds of approximately \$15,000 were committed from an underspend in the Federal Government funded Enhanced management of Ramsar site wetlands within the Great Sandy Strait (GSS) catchments project. However no other funds to make up the \$45,000 shortfall were able to be sourced and the \$15,000 was returned to the funding body.
