Final Draft Plan

This Version: 4/04/2014

Normanby Catchment Water Quality Management Plan

Australian Rivers Institute Griffith University

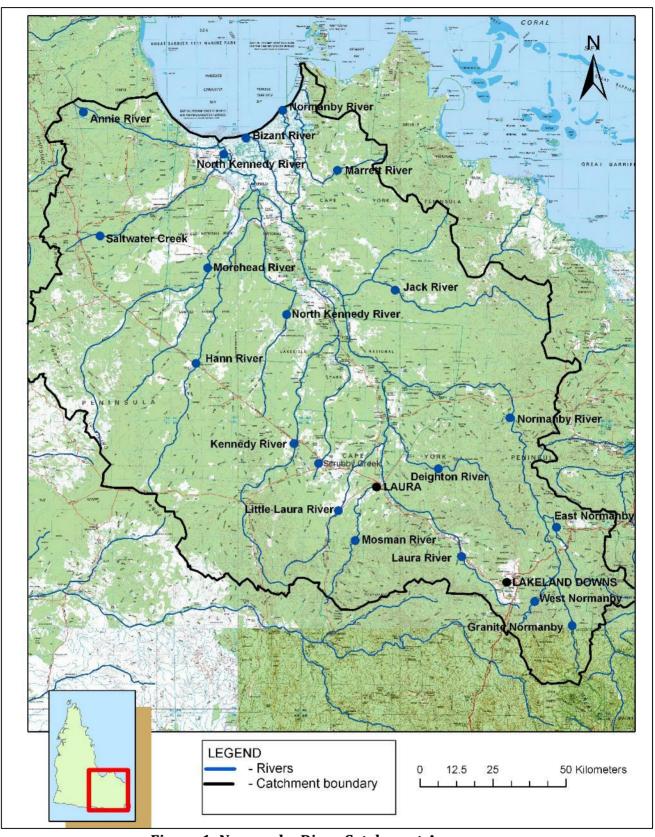
Figure 1: Normanby River Catchment Area (Normanby and Hann sub-basins combined)

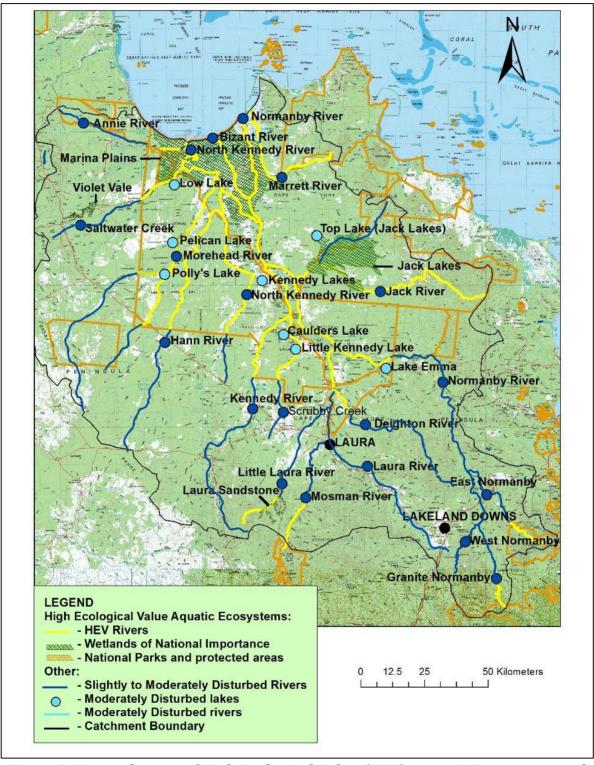
Figure 3: Mapped Areas of High Ecological Value (HEV) Aquatic Ecosystems and Existing Conservation Areas within the Normanby Basin This figure is not final

Aquatic ecosystem condition and biological diversity remain poorly documented for many parts of the Normanby Basin, particularly outside of conservation areas. Detailed, onground assessments of the ecological values and integrity are required to better define HEV areas for the Basin as well as Slightly, Moderately or Highly Disturbed areas. Areas of HEV aquatic ecosystems that have been documented within the Normanby River Basin (Figure 3) are discussed in the following sections.

Jack Lakes, part of the Jack River NP, is an inland freshwater lake system covering 808 ha (Figure 3). The lakes flow south into the Jack River, which flows southeast into the Normanby River. The Lakes provide important dry season refuge for migratory waterbirds such as the magpie goose (*Anseranas semipalmata*), a much valued food source for the Traditional Owners of CYP. Flocks of over 1,000 geese have been observed at Jack Lakes, in addition to a high density of Wandering Whistling-Duck (*Dendrocygna arcuata*), Radjah Shelduck (*Tadorna radjah*) and Pacific Black Duck (*Anas superciliosa*). The wetlands also support large populations of freshwater turtles and fish (Stephan & Howley 2009). The Lakes (with the exception of the "Top Lake") and Jack River are considered to be HEV or Slightly Disturbed ecosystems.

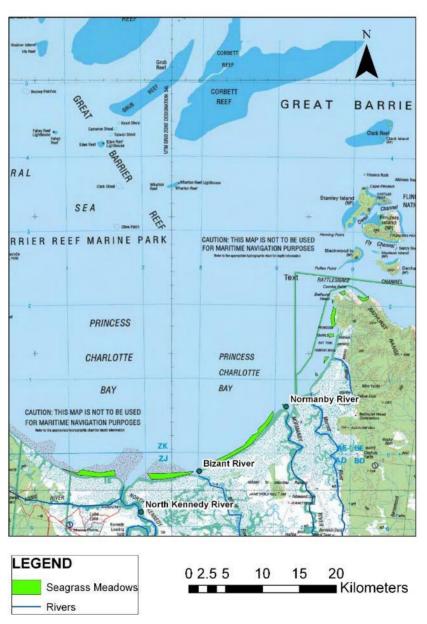
Figure 4: Princess Charlotte Bay and the Great Barrier Reef showing coastal seagrass meadows

Princess Charlotte Bay (PCB) (Figure 4) is recognized both for its diverse coastal wetlands and rich marine ecosystems including extensive seagrass meadows and coral reefs. The Bay and its associated ecosystems are considered to be HEV on the basis of its intact seagrass meadows, coral reefs, fisheries values, and current conservation zonings discussed below and shown in Appendix B.

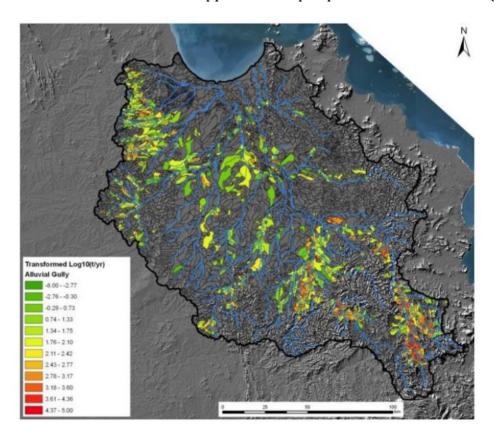
Figure 9: Distribution and rates of erosion of alluvial gullies in the Normanby catchment. (Red areas indicate the highest rates of erosion; Source: J. Spencer, Brooks et al. 2013)

A significant increase (10x) in alluvial (floodplain) gully erosion has been measured post-European settlement, associated with the introduction of cattle, overgrazing, and soil disturbance (Brooks et al. 2013, Shellberg and Brooks 2013). Alluvial gully erosion occurs primarily in areas of sodic soils on elevated floodplains and terraces (river frontage) and is actively eroding more than 7000 ha of land in the Normanby catchment (Brooks et al. 2013, Shellberg and Brooks 2013). Areas of concentrated alluvial gully erosion occur along the West Normanby and Granite Normanby Rivers in the southeast (Figure 9; Figure 16). Other major areas of alluvial gully erosion include the East & West Normanby confluence and tributaries of the Normanby River upstream from Battle Camp Road. Along the Laura River, the worst gully erosion is between the Laura Dance Festival grounds and Carrolls Crossing. To the west, a modest density of gullies occurs on the Mossman, Hann & North Kennedy Rivers and in the upper catchment of Saltwater Creek (Figure 9).

Concentrated areas of alluvial gully erosion and soils with high erosion risk have been identified for the catchment (Figure 9; Figure 16). Specifically, large river frontage paddocks on four main cattle properties in the upper catchment contain the bulk of the eroding gullies, and these frontage paddocks are where cattle tend to congregate. These are the priority areas (Figure 16) for investments in erosion reduction measures using large-scale land management changes and localised intensive rehabilitation actions to reduce sediment yields to downstream rivers, wetlands, estuaries, coasts, and reefs.

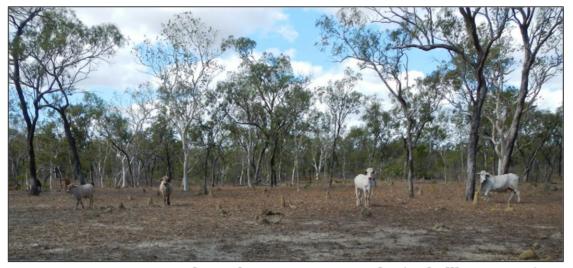
Figure 10: Cattle on the Granite Normanby (J. Shellberg, 2013)

Without best management practices, cattle can directly and indirectly impact on water quality causing increases in nutrient loads, erosion, sedimentation, and bacteria. Direct impacts from cattle include reduction of grass cover, disturbance of river banks and destruction of riparian vegetation. Indirect impacts associated with the grazing industry include the spread of weeds and altered fire regimes, both of which can reduce perennial grass cover and increase water and sediment run-off. Road, fence and track networks to service the industry also cause erosion. A more detailed analysis of the impact of cattle and other land-use disturbances in the Normanby is provided by Shellberg and Brooks (2013).

Deep cattle pads worn into steep river banks and adjacent areas cut into highly erodible sodic soils and can initiate alluvial gully erosion ("breakaways"). Accelerated water run-off from reduced grass cover also promotes the development of alluvial gullies (Brooks et al. 2009; Shellberg 2011, Shellberg and Brooks, 2013). **The rate of gully erosion along river frontage areas has increased by up to ten times in some parts of the upper catchment since the introduction of cattle** (Brooks et al. 2013; Shellberg and Brooks, 2013).

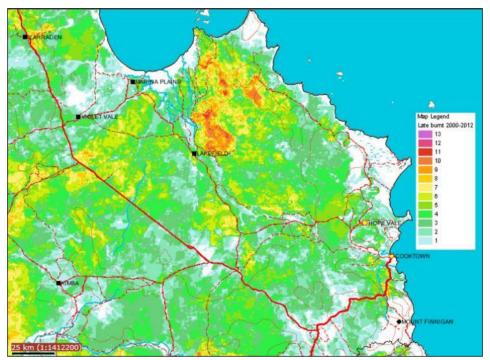
Figure 13: Frequency (number of years) of late dry season burns in the Normanby catchment between 2000 – 2012 (NAFI 2013a)

Traditional Owners and other land managers are concerned about the frequency of late dry season fires in the Normanby catchment (tkrp.com.au). Fire history maps show that more than 85% of the catchment has experienced at least 2 late burns within the past 12 years and more than 45% of the catchment has burnt late 4 or more times in that period (NAFI 2013a). The most frequent late burns occur in the lower catchment on the east side of the Normanby River (Kalpowar region) and in the Morehead and Hann River catchments (Figure 13). (*Late burns are defined by NAFI as fires occurring between August- December; these percentages may include prescribed storm burns*).

Areas highly susceptible to erosion such as river frontage areas with sodic soils prone to alluvial gully erosion should be burnt very infrequently or never (Shellberg and Brooks 2013). Anderson et al. (1988) recommended patch-burning areas susceptible to erosion with low intensity fires no more than every 3 years either in the early-wet season or early-dry season. Over the past 12 years, at least 40% of the catchment has been burnt more than every three years (NAFI 2013b).

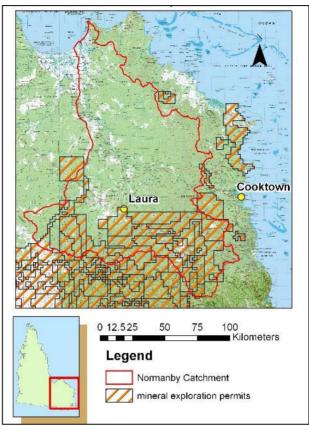
Figure 15: Current Mineral Exploration permit applications in the Normanby Catchment (Qld DNRM 2012)

Mine exploration in the upper catchment poses significant threats to both the cultural and aquatic values of the Laura Sandstone springs and Laura, Little Laura and Mosman Rivers. The extraction of groundwater for mining could reduce water flows at groundwater springs at the Laura Sandstone and downstream groundwater dependent ecosystems. Earthworks, including the development of roads through highly erodible soils (Figure 16 and Figure 17) are highly likely to increase erosion and suspended sediment levels in the Laura or Normanby Rivers.

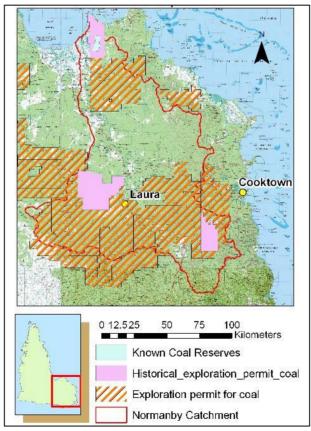
Figure 16: Current and Historic Coal Exploration Permits and Known Coal in the Normanby Catchment (Qld DNRM 2012)

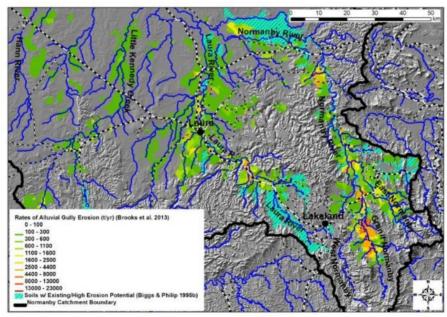
Figure 16: Erosion "Hotspots" in the upper catchment (red and orange = areas with the highest rates of erosion, turquoise = highly erodible soils)

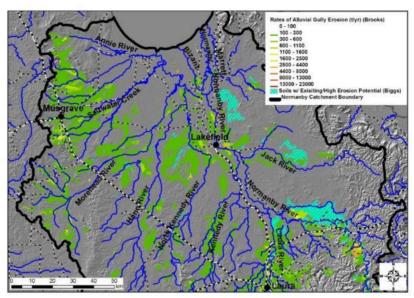
Figure 17: Erosion "Hotspots" in the lower catchment (red and orange = areas with the highest rates of erosion, green= moderate rate of erosion, turquoise = highly erodible soils)

In addition to these concentrated "hot spots" of gully erosion, erosion from widespread road, fence, feral pigs and stream bank sources can have significant impacts on High Environmental or High Cultural Value aquatic ecosystems. Therefore to reduce total sediment loads, improved management practices need to be adopted across the Normanby catchment, particularly in areas of existing erosion or erosion prone soils (Figure 17). Targeted rehabilitation actions will also be appropriate at specific HEV sites outside of the mapped hot spots for erosion. Roads and fences can be addressed by improved design and maintenance practices. Erosion from small stream banks needs to be addressed through improved management of grass cover to reduce water runoff and increase bank stability. Fire can be used at appropriate locations, times and frequency across the catchment to protect and improve grass cover in erosion sensitive areas by the end of the dry season. Culling and exclusion fences will reduce feral animal impacts on HEV wetlands.

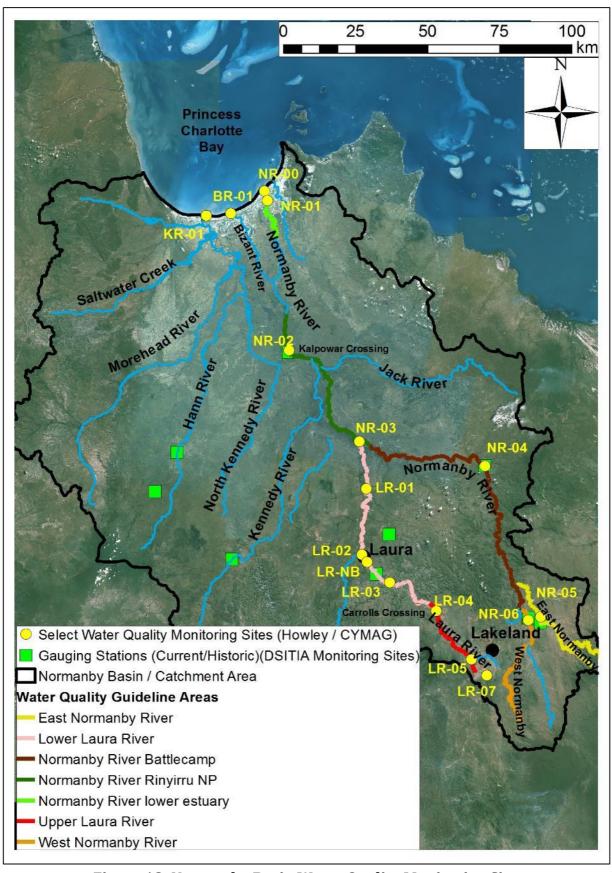
Figure 18: Normanby Basin Water Quality Monitoring Sites, Gauging Stations and Water Quality Guideline Areas

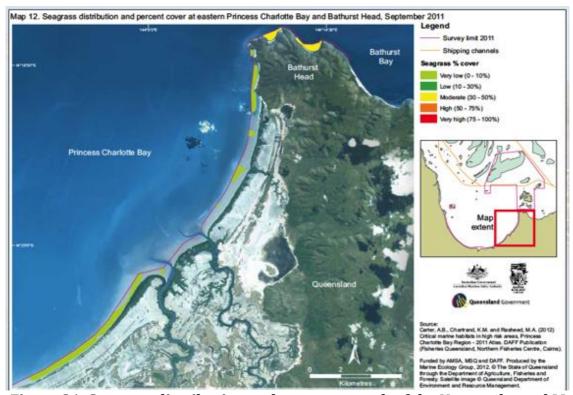
Figure 21: Seagrass distribution and cover at mouth of the Normanby and Marrett Rivers

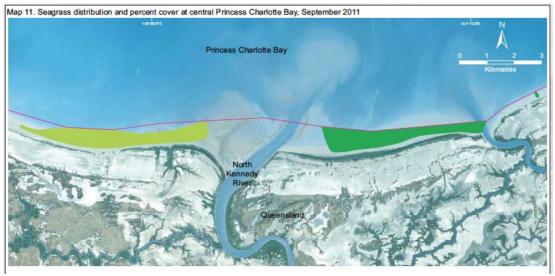
Figure 22: Seagrass distribution and cover at mouth of the North Kennedy River

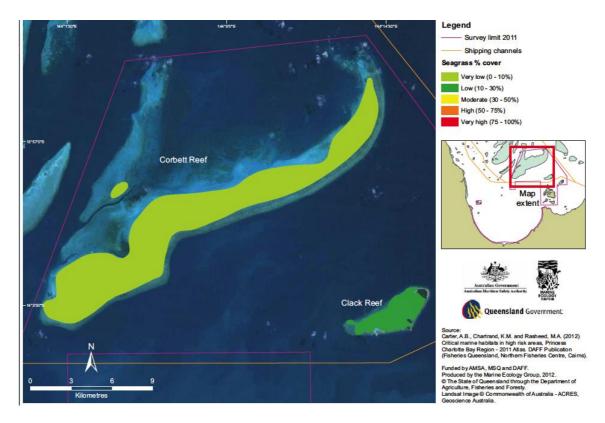
Figure 23: Seagrass cover on Corbett and Clack Reefs, PCB

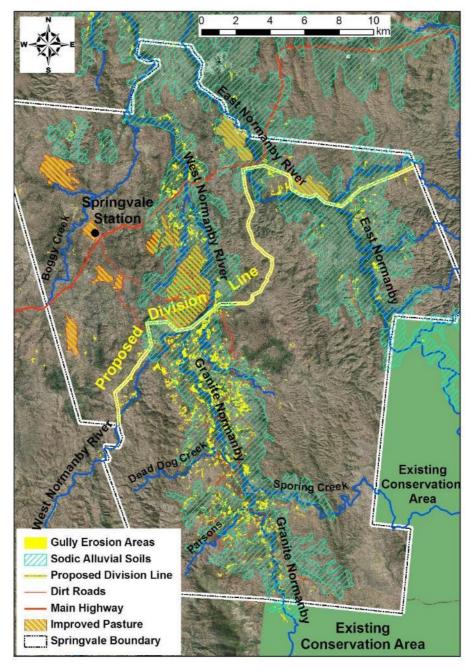
Figure 24: Proposed Cattle Exclusion/ Conservation Zone on the Granite Normanby River
