Inventory of Instream Structures Impacting on Ramsar Wetlands

July 2011

The project Inventory of Instream Structures Impacting on Ramsar Wetlands (the project), completed in May 2010 and the focus of this report, was managed by Fisheries Queensland, a service of the Department of Employment, Economic Development and Innovation (DEEDI) and funded as part of the Queensland Wetlands Program (the Program). The project employed a framework and guidelines to identify priority structures impacting on wetland condition and fish habitats in the Bowling Green Bay (BGB) Ramsar site and the Bowling Green Bay declared Fish Habitat Area (FHA) near Townsville, and the Shoalwater and Corio bays Ramsar site and Corio Bay declared FHA near Yeppoon.

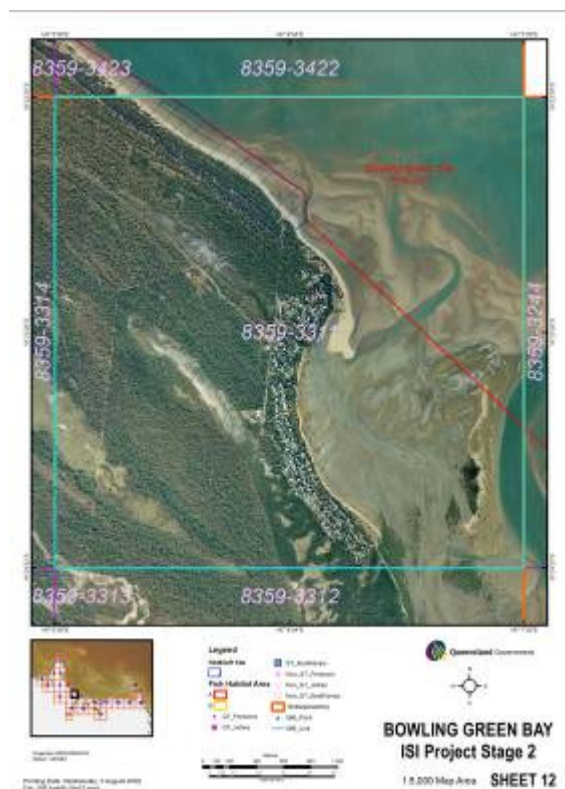
This enabled fieldwork progress to be monitored. Each grid square was numbered consecutively for ease of reference. Individual maps were subsequently created for each numbered grid square and used for field navigation. An example of an individual map for the Bowling Green Bay project area is shown in Figure 4. Key maps for the Bowling Green Bay and Shoalwater and Corio bays project areas are included in appendices D and E respectively.

Figure 4. Individual Map 8395-3311 - Bowling Green Bay project area
