# Barratta Creek wetlands

## Project summary

The Barratta Creek wetlands Pilot Program has produced the *Freshwater wetlands of the Barratta Creek catchment management investment strategy*, using:

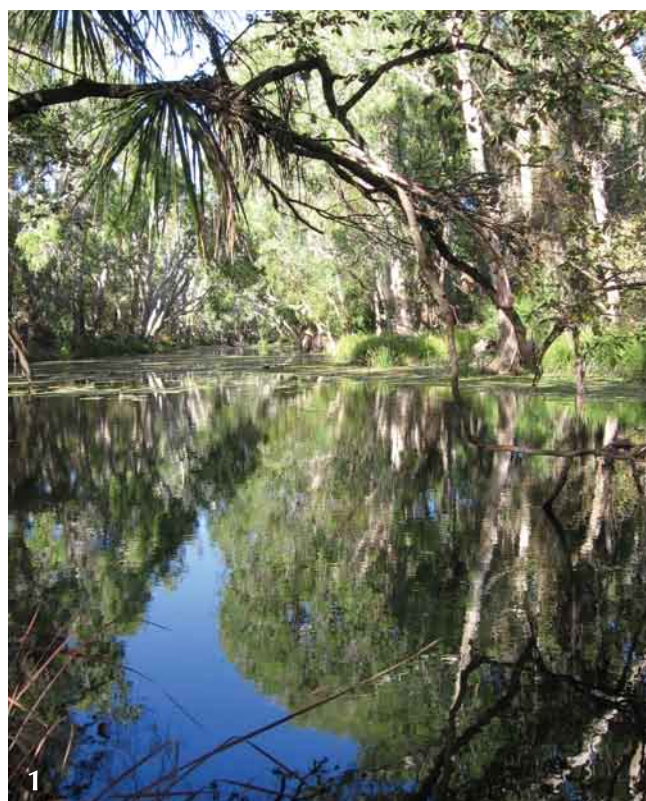
Photo 1: The Barratta Creek catchment retains some of the most unspoilt deepwater lagoons left in the region (photo: Jim Tait)

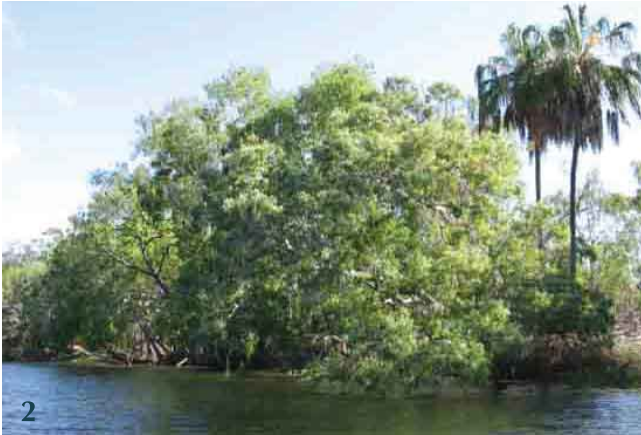
Photo 2: Healthy riparian vegetation within Jerona Wetland aggregation (photo: Jim Tait)

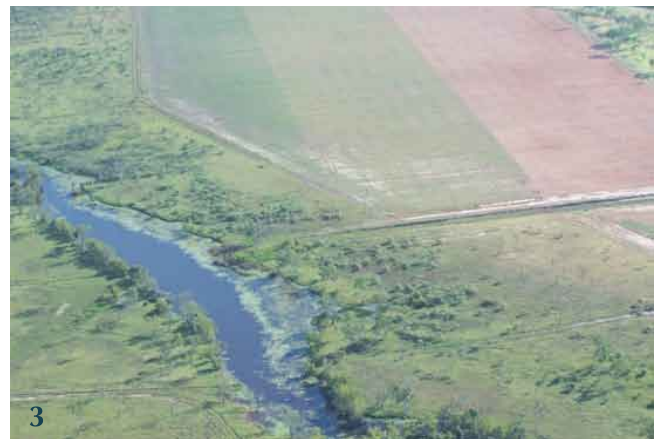
Photo 3: Irrigation tailwater discharge to high-value remnant lagoon in upper Barratta Creek catchment (photo: Jim Tait)

Historically, Barratta Creek catchment has been grazing land, but more recently there has been **land-use intensification** towards sugarcane production. The associated nutrient and tailwater inputs, along with lack of grazing, have resulted in infestations of **invasive grasses** (hymenachne and para grass) and **woody weeds** (particularly chinee apple) within riparian and woodland habitats. The absence of managed **fire and grazing regimes** has resulted in hot annual fires that damage native vegetation and diversity. Much of the irrigation area surrounding the Barratta Creek catchment is affected by rising groundwater, which, combined with tailwater releases, has changed the hydrology of the Creek system from seasonal to almost perennial. Nutrient loads in tailwater also damage **water quality** and encourage **aquatic weeds** such as salvinia, which to date has been partially managed by biological control.

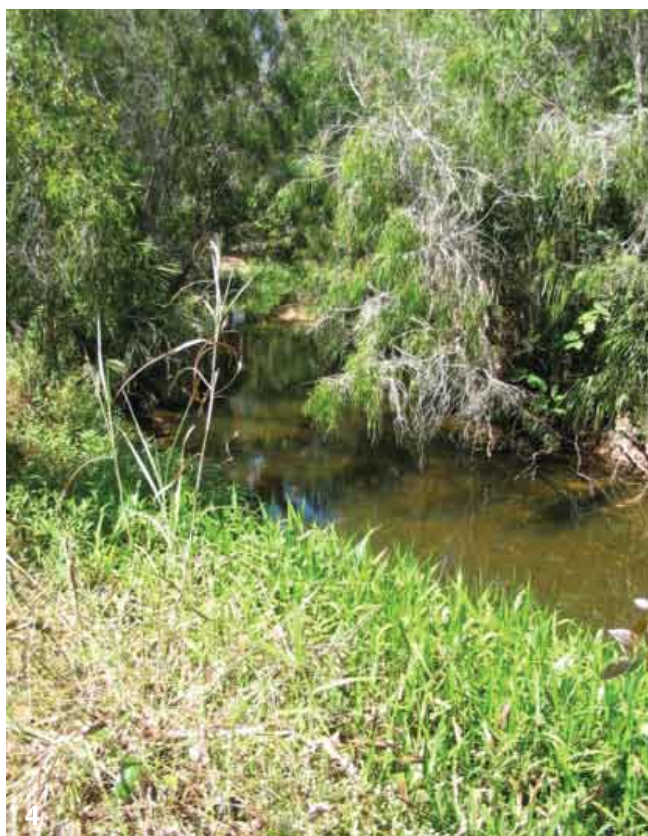
Photo 4: In the absence of grazing, 'protected' areas of Barratta Creek are being invaded by hymenachne, highlighting the role of controlled grazing for floodplain wetland management (photo: Jim Tait).
