Horseshoe Lagoon

The Great Barrier Reef Coastal Wetlands Protection Program Pilot Program was commissioned by the Australian Government to deliver on-ground actions for the sustainable management of 22 priority wetlands in the Great Barrier Reef catchment. The \$2 million program was delivered over two years by a consortium led by Conservation Volunteers Australia and involved partnerships between government, community and landowners to identify and protect these wetlands.

Project summary

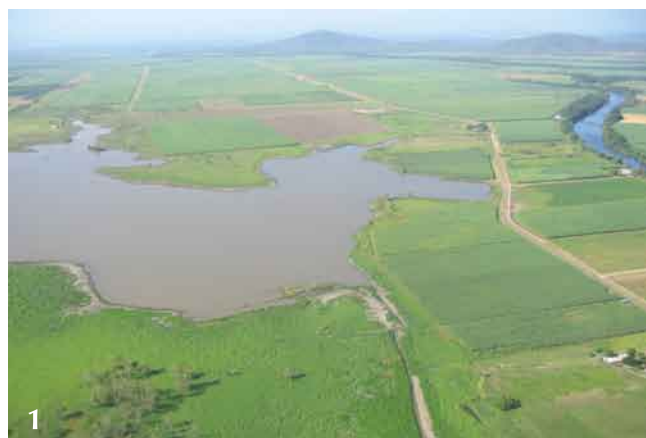
Horseshoe Lagoon receives its water mainly through groundwater and irrigation tailwater, and in large flood events through bank overflow from the Haughton River. The tailwater inputs usually keep the lagoon at full water level, which is an unnatural state that alters its natural wetting and drying cycle. Water exits Horseshoe Lagoon via a constructed channel, although during large flood events it flows out across a broader area.

Photo 1: Aerial photo of Horseshoe Lagoon (photo: Jim Tait)

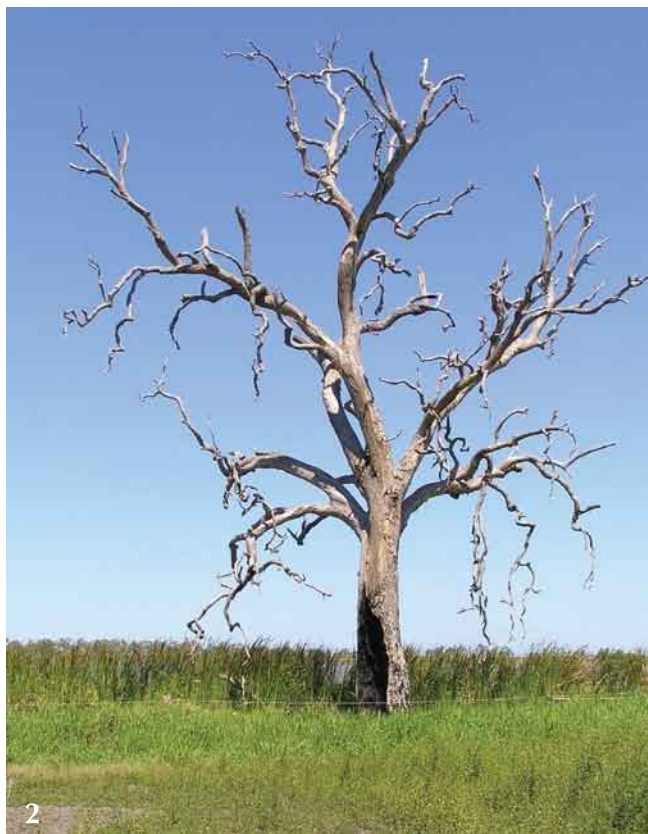
Photo 2: Paperbarks dead as a result of hot fires and weakening by waterlogging (photo: Jim Tait)

Riparian vegetation around the lagoon's margin is sparse, and mostly dominated by introduced para grass and hymenachne. A few remnant melaleuca and leichhardt trees survive on the banks, although some of these are now severely stressed by frequent hot fires and constant waterlogging.

Grazing and fire burning regimes within the lagoon area have caused major damage to the ecological condition of Horseshoe Lagoon. The riparian vegetation has been affected by fires that are too hot and too frequent. Excessive stocking and grazing pressure have caused:

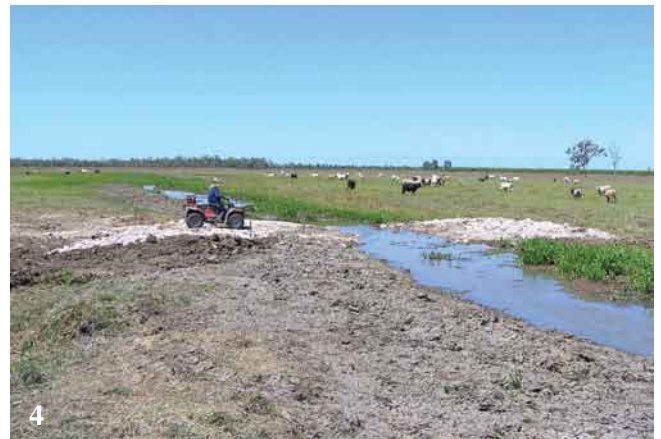
Photo 4: Rock erosion control structure installed in outlet channel of Horseshoe Lagoon (photo: Jim Tait)

The constructed outlet channel, where water exits the lagoon, frequently becomes invaded with hymenachne. The weed invasion results in degraded water quality and blockages to normal water flow. Additionally, floodwaters can dislodge and rip out the weed, often taking with it the sediment in which it is rooted and exacerbating **erosion**.

Preliminary investigations were completed and a detailed design prepared for a **water control structure** to help manage water levels. This work included extensive consultation with stakeholders. After further negotiations, agreement was obtained to install two minor rock erosion control structures across the outlet drain; but this is merely a short-term measure to mitigate the risk of erosion at the discharge drain if there is major flooding (see 'Further reading' below).

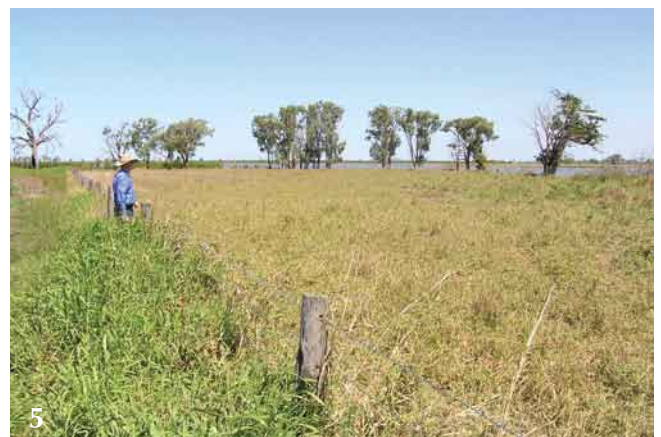
Photo 5: Fences erected to allow strategic heavy grazing, control invasive exotic grasses and encourage natural regeneration of riparian vegetation (photo: Jim Tait)

Management of grazing and fire regimes was accepted by stakeholders as a means of promoting good ecological condition. This required fencing of remnant vegetation and reintroduction of cattle to:

- reduce exotic grass biomass (i.e. hymenachne) and therefore fuel loads
- encourage regeneration of native trees.
