NOOSA SHIRE – WATERWAYS ASSESSMENT 2017

AN ASSESSMENT OF NOOSA WATERWAYS TO INFORM THE
NOOSA PLAN & REHABILITATION STRATEGIES

September 2017

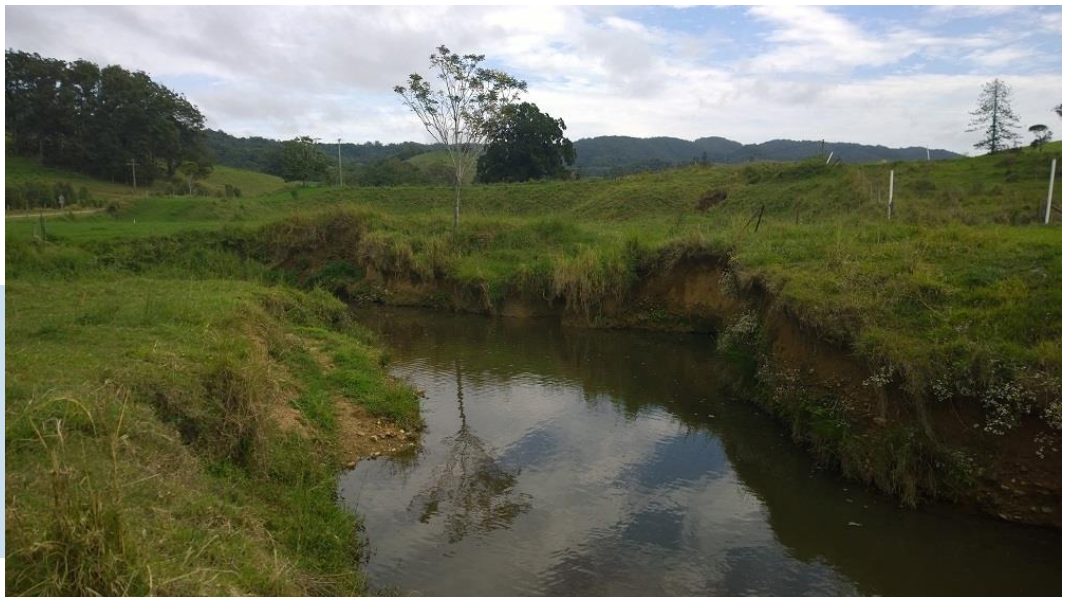
*Pinbarren Creek
(PIN 1) - Bed and
Bank Erosion and
absence of riparian
vegetation.*

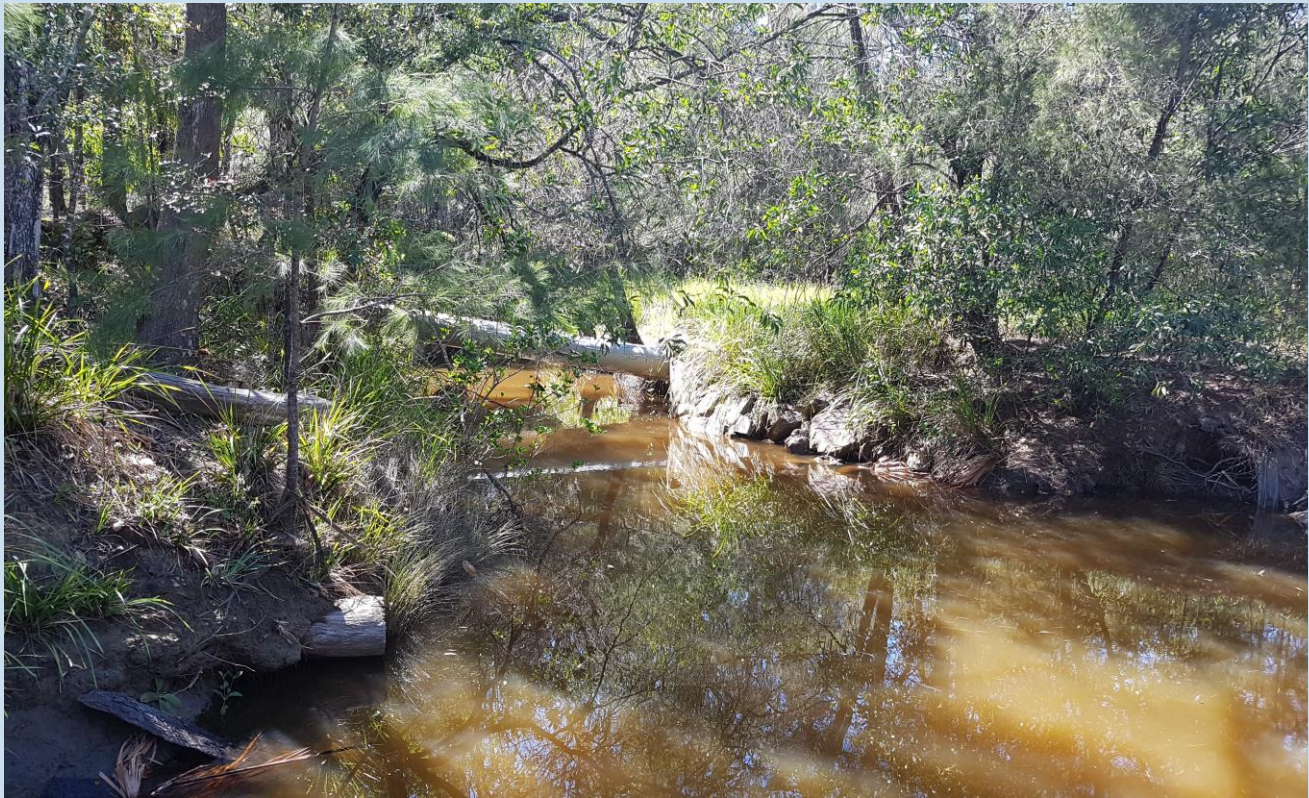
Cooroibah Creek (COH3/4), on entry to 4 Ways Reserve – A Multi-channeled creek has been realigned due to road and pipe infrastructure, causing streambed alterations and aquatic habitat condition decline.

as creating a de-stabilising effect to the culvert structure itself though undermining. Streambed erosion inevitably leads to streambank erosion as the bed of the stream re-compensates for bank stability forming a new angle of repose. Overall there is a general loss of fluvial geomorphic features and habitat diversity required for aquatic life such as fish. An example of this can be observed at Cooroibah Creek on McKinnon Drive. Upstream of McKinnon Drive, the multi-channel Cooroibah Creek flows out of National Park in excellent condition, however below McKinnon Drive the waterway is forced into a newly aligned steep, deep single channel of low geomorphic diversity eventually re-entering the original waterway at Four Ways reserve. The creek also crosses a sewage pipeline which is likely to have compounded the reason for the stream realignment.

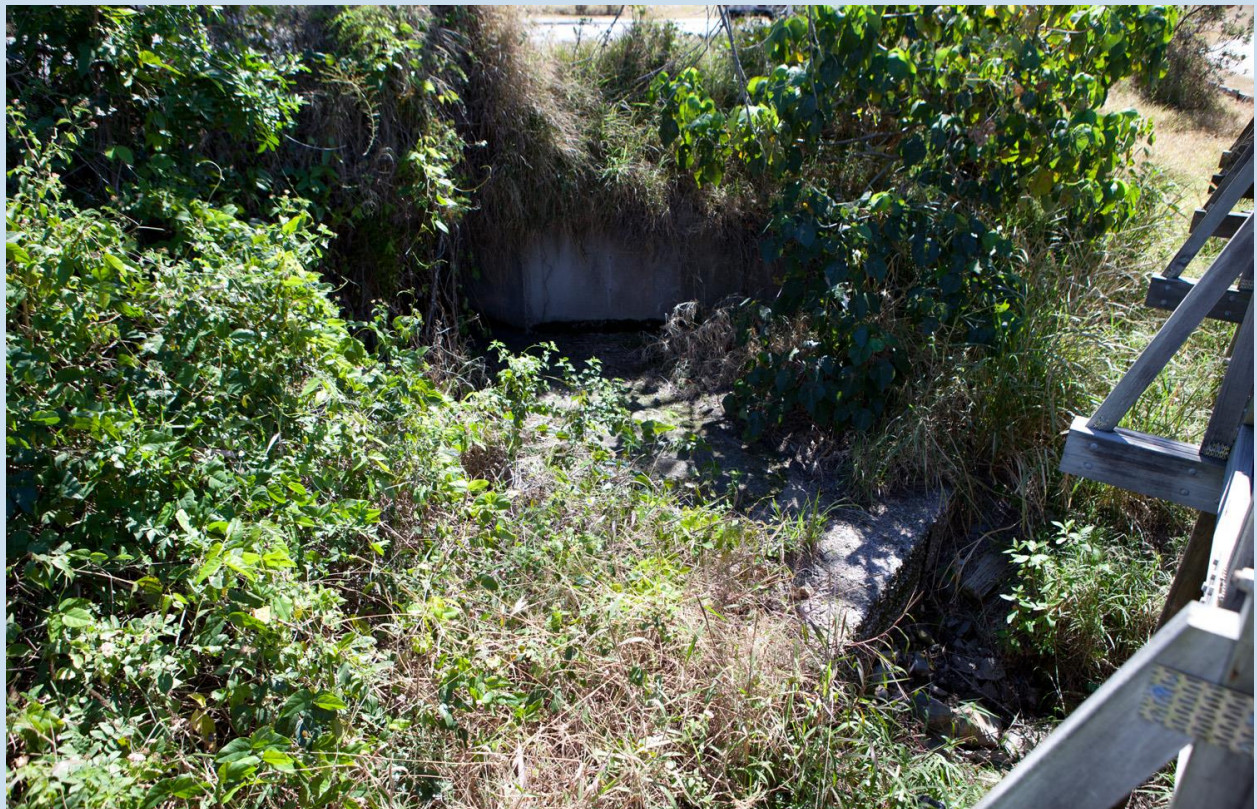
Marcus Creek at David Low Way (MCS 2) – Single Culvert crossing with significant 'drop-off' causing fish passage restriction and stream bed erosion.

A common issue observed was the difficulty passing a broad waterbody into a single culvert point when these waterways became urbanised near housing or road networks (similar issues to that examined above). These waterways are relatively steep in their lower catchment which poses difficulties locating road culverts (particularly on David Low Way), without a significant 'drop-off' that causes fish passage and stream bed erosion issues. A good example is Marcus Creek on David Low Way. Significant weed infestations were observed near urbanisation which additionally degrades the integrity of these waterways.
