Great Sandy Strait Biopassage Remediation Project – Final Report

REDUCING THREATS TO THE GREAT SANDY STRAIT RAMSAR
WETLAND & COASTAL SYSTEMS

November 2012

Report to the Burnett Mary Regional Group for Natural Resource Management

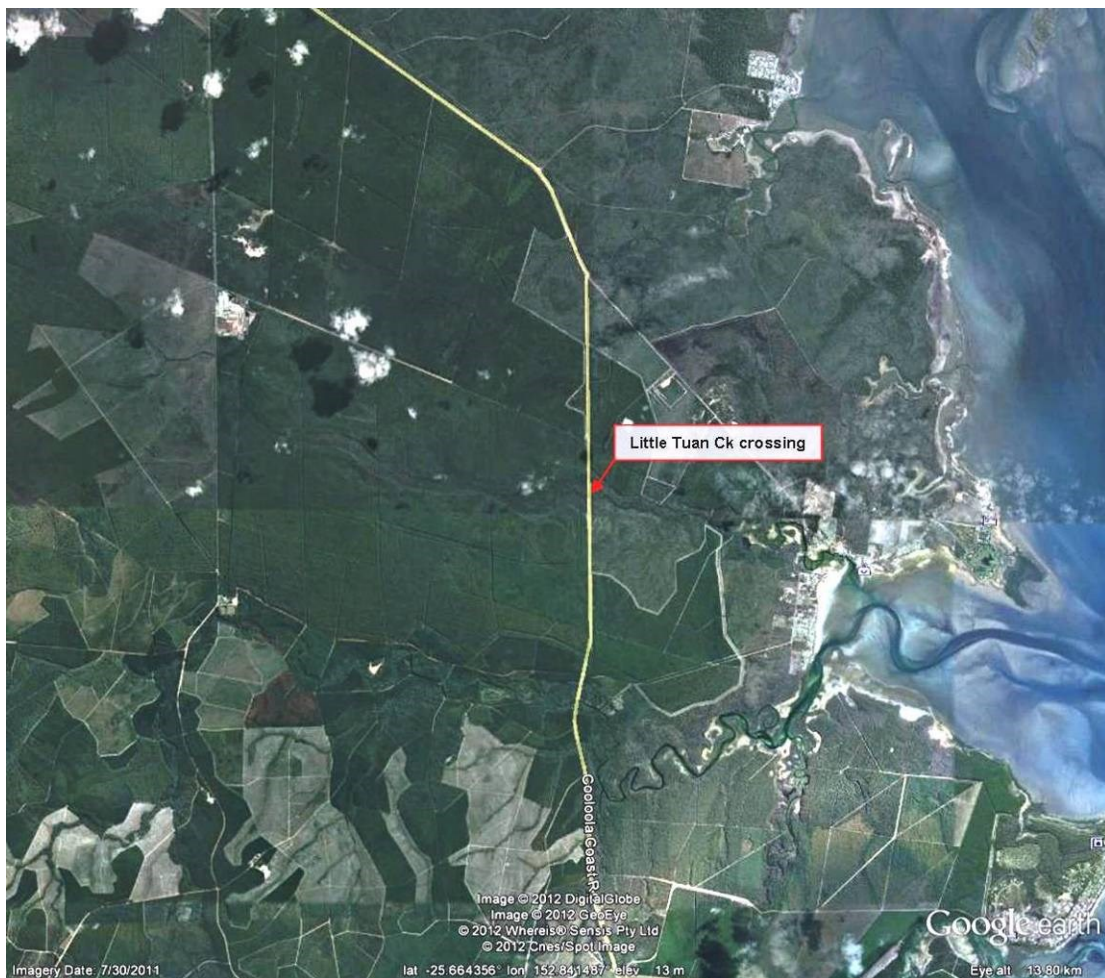
The Little Tuan Creek commences on a low rise on the eastern side of Tinana Creek sub-catchment and flows east until joining with Tuan Creek near the coastal town of Boonooroo (Figure 8). The crossing of Little Tuan Creek by the Coolooloa Coast road is approximately 5.79 km upstream of the coast and is the most downstream crossing of the creek. The Little Tuan Creek continues for approximately 7 km upstream of the crossing. The dominant land use in the Tuan Creek catchment is plantation softwood which is grown up to a narrow (<100 m) strip of natural riparian vegetation along the creek. The habitat upstream of the crossing is typically wallum with shallow meanders and no defined waterholes.

Figure 8. Aerial image of the Tuan Creek catchment indicating the location of the Coolooloa Coast Road crossing of Little Tuan Creek.

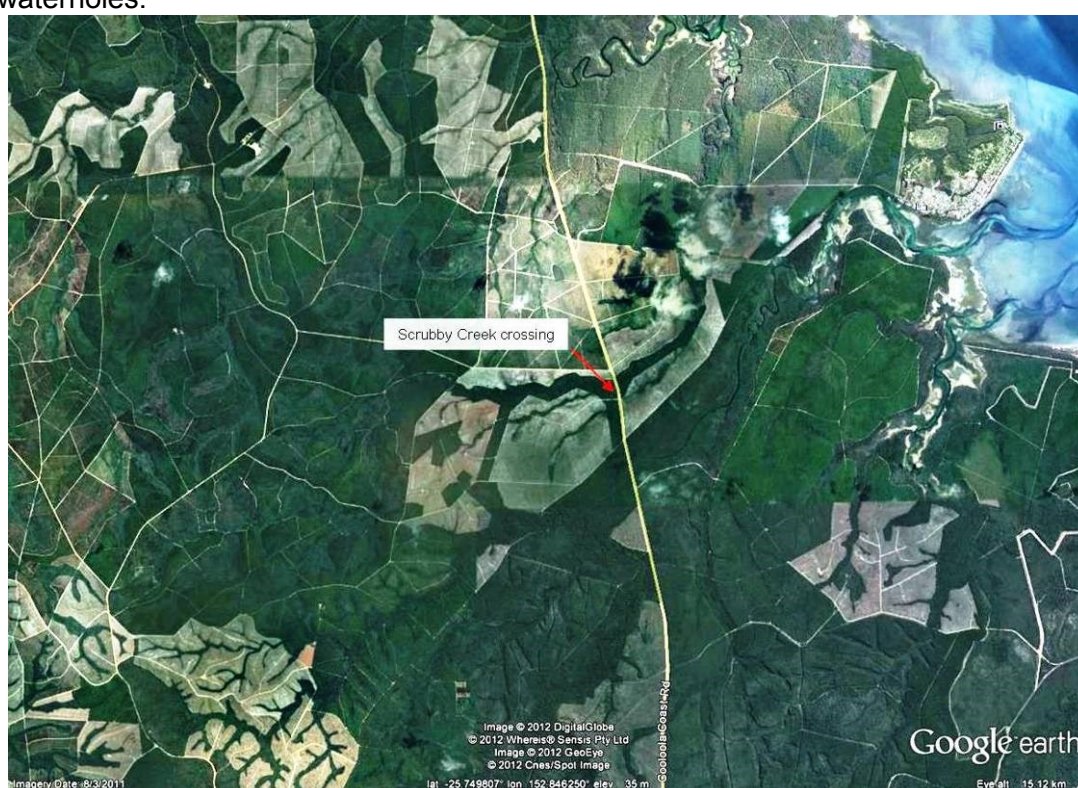
Scrubby Creek is a southern tributary of Tuan Creek that commences on a low rise adjacent to Logging Creek on the Tinana Creek sub-catchment and flows east until joining with Tuan Creek near the coastal town of Boonooroo (Figure 13). The crossing of Scrubby Creek by the Coolooloa Coast road is approximately 10.2 km upstream from the coast and is the most downstream crossing of the creek. Scrubby Creek continues for approximately 8 km upstream of the crossing. The dominant land use in the Tuan Creek catchment is plantation softwood which is grown up to a narrow (<100 m) strip of natural riparian vegetation along the creek. The habitat upstream of the crossing is typically wallum with shallow meanders and no defined waterholes.

Figure 13. Aerial image of the Tuan Creek catchment indicating the location of the Coolooloa Coast Road crossing of Scrubby Creek

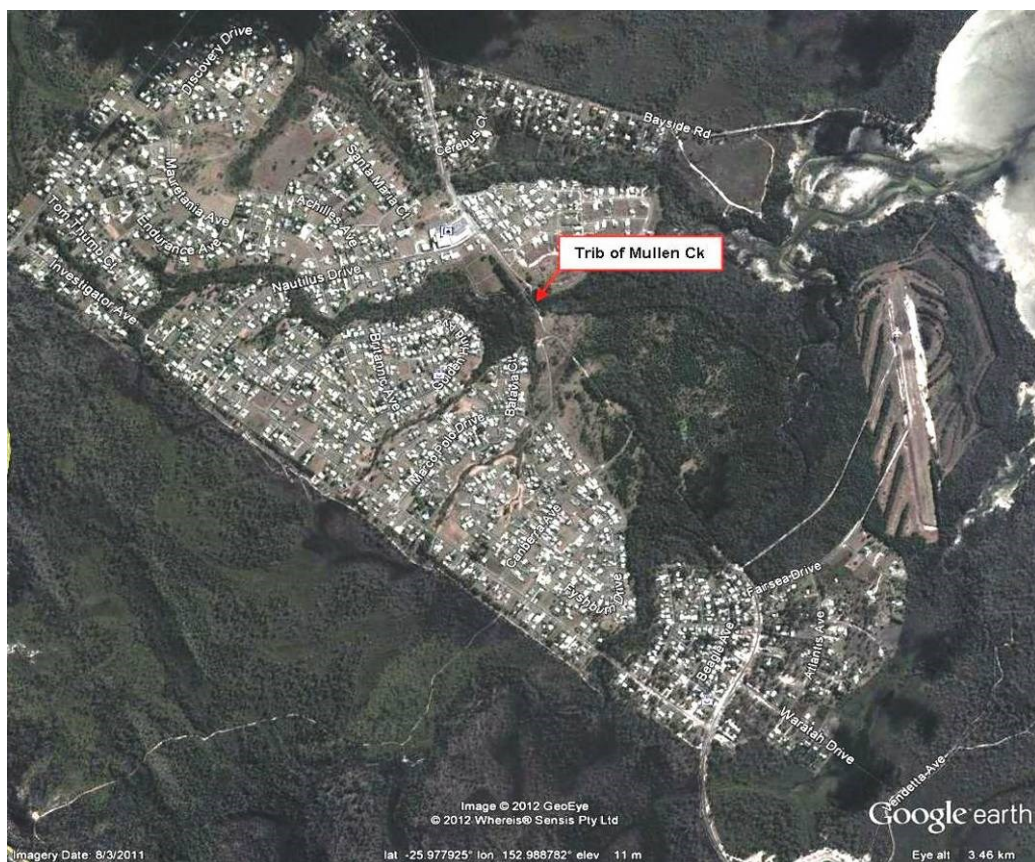
Figure 17. Aerial image of the Mullen Creek catchment indicating the location of the Queen Elizabeth Drive crossing of the Trib of Mullen Creek site.

The Trib of Mullen Creek crossing is on Queen Elizabeth Drive and is a low level structure consisting gravel and rock utilised by recreational off-roaders and bushwalkers. Prior to remediation, the lowest point of the crossing was set above the natural bed level with a low slope of gravel, large rocks and debris extending approximately 15 m downstream (Figure 18). All flows in the creek passed over the crossing and through or over the gravel, rocks and debris. The passage of aquatic fauna during low flows was hampered by the arrangement of the rocks and gravel bars formed from erosion of the crossing during flows.

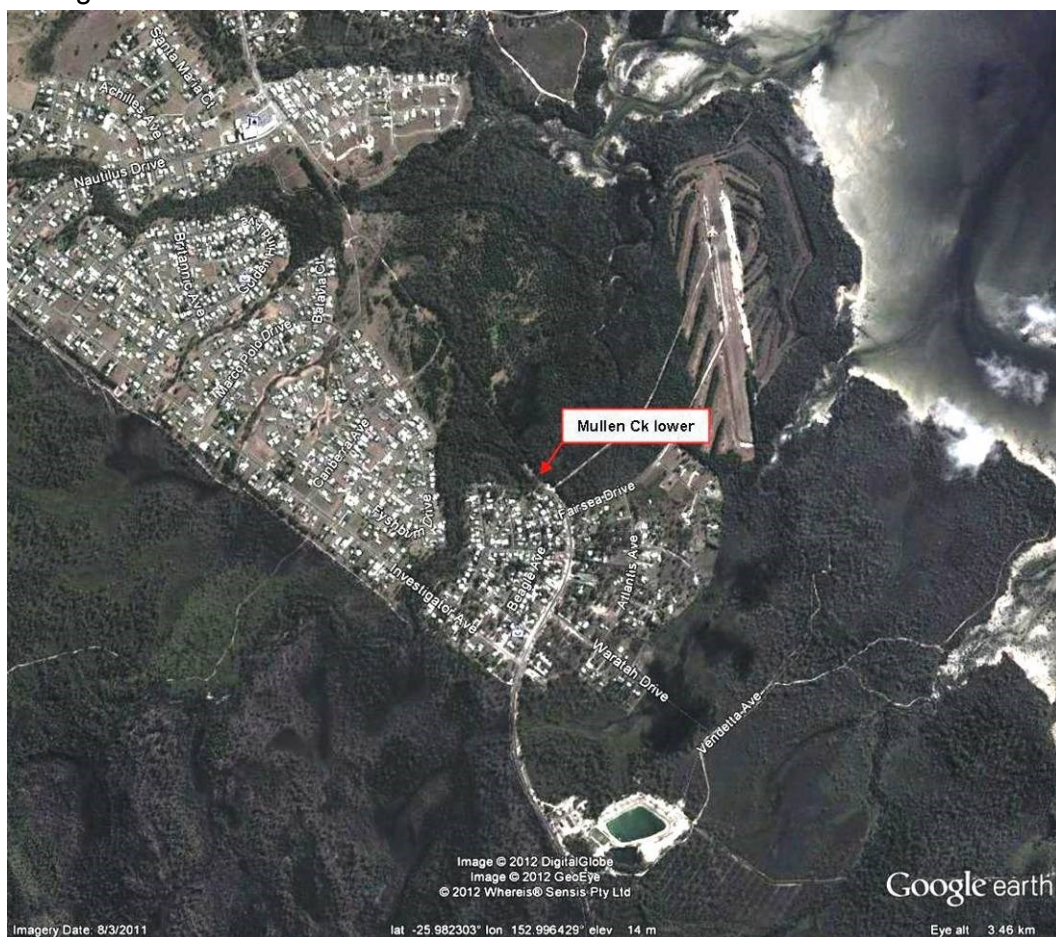
Figure 20. Aerial view of the Mullen Creek catchment indicating the location of the Queen Elizabeth Drive crossing of the Mullen Creek Lower site

The Mullen Creek lower crossing is on Queen Elizabeth Drive and is a low level structure consisting gravel and rock utilised by bushwalkers, recreational off-roaders and the Gympie Regional Council for access to pumps. Prior to remediation the lowest point of the crossing was set above the natural bed level with a low slope of gravel, and rocks extending downstream (Figure 21). All flows in the creek passed over the crossing and through or over the gravel, rocks and debris. The passage of fish during low flows was hampered by the arrangement of the rocks and gravel bars formed from erosion of the crossing during flows.

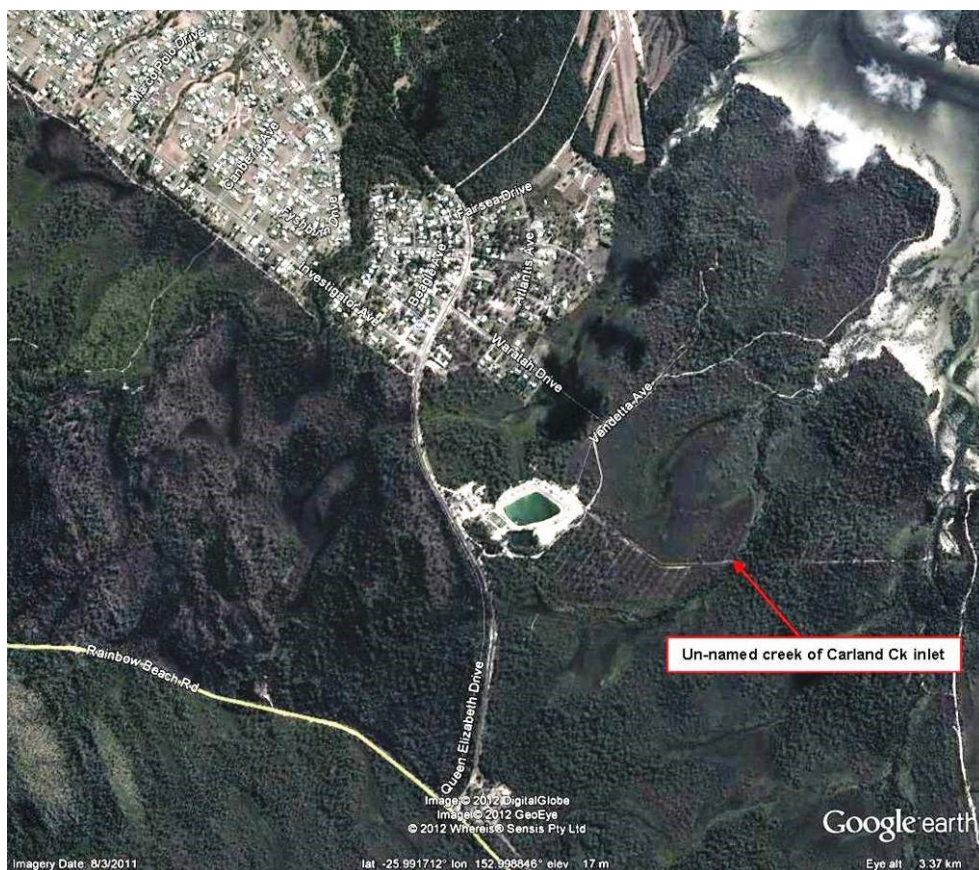
Carland Creek commences on a low ridge adjacent to the Noosa River catchment and flows north into Tin Can Bay to the east of Cooloola Cove Village (Figure 23). No biopassage barriers were identified on Carland Creek however a crossing was found on an un-named creek to the east that flows into the Carland Creek inlet. The crossing is on an access track that leads from the rear of the Cooloola Cove sewage treatment plant east to Carland Creek. The track on both sides of the crossing was severely eroded and appeared to be used very infrequently.

Figure 23. Aerial image of the Carland Creek catchment indicating the location of the Un-named creek of the Carland Creek inlet site.

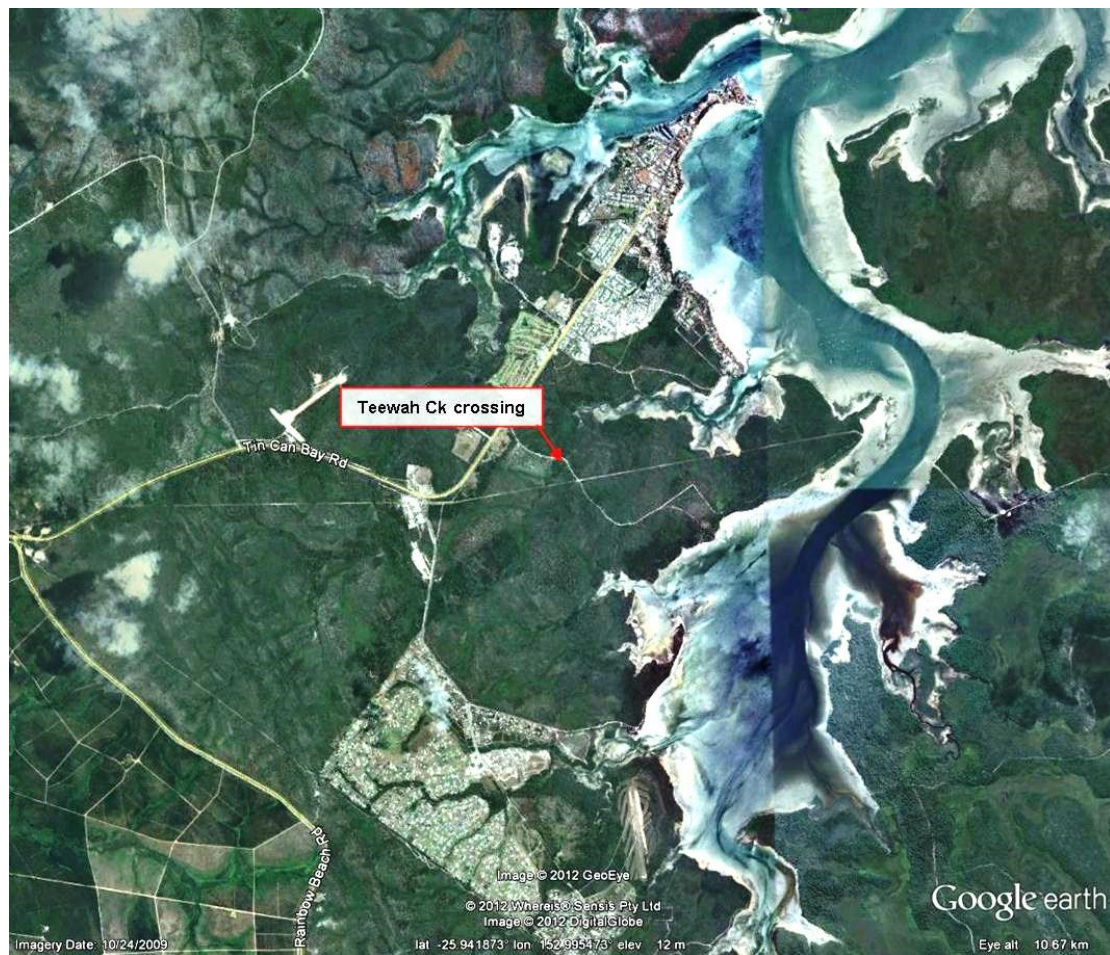
Teewah Creek commences on a low ridge bordered by Bayside Road and flows north-east into Tin Can Bay terminating to the south of Tin Can Bay Township (Figure 27). The crossing of Teewah Creek is on Teewah Point Road a public road that is used to access private properties and Teewah Point in the great Sandy Straits. The crossing is approximately 3.18 km from the coast. Upstream of the crossing is natural bushland with intact riparian cover and shallow but high quality waterholes and downstream is paperbark wetland and the mangrove lined estuarine inlet. The crossing is the only artificial barrier on the creek which terminates approximately 2.5 km upstream. The quality of the habitat and data from the fish survey in March 2012 indicates that remediation of biopassage to the crossing should be given a high priority

Figure 27. Aerial image of the Teewah Creek catchment indicating the location of the Teewah Creek crossing site on the Teewah Point Road.

No biopassage remediation works were performed within the current project at the Teewah Creek crossing. A cost estimate for the removal of the current pipe culvert and replacement with a baffled 2.4 m wide box culvert was estimated by Gympie Regional Council to be a minimum of \$60,000 (Greg Ingham GRC pers com.). The cost of remediating this site was beyond the budget of the current project. Funds of approximately \$15,000 were committed from an underspend in the Federal Government funded Enhanced management of Ramsar site wetlands within the Great Sandy Strait (GSS) catchments project. However no other funds to make up the \$45,000 shortfall were able to be sourced and the \$15,000 was returned to the funding body.
